MODEL
2011~2016MY
Optima Hybrid
(TF HEV)

NUMBER
PS391

OPTIMA HYBRID (TF HEV) WITH DTC B1695 - LOST
COMMUNICATION WITH E-COMP

GROUP TRA	MODEL 2014~2015MY Cadenza (VG)
	NUMBER 056	DATE August 2015
TECHNICAL SERVICE BULLETIN		
SUBJECT: TCM UPGRADE – SHIFT LOGIC IMPROVEMENT

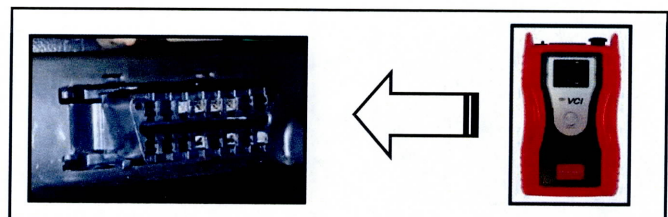
4. Connect the Main 16-pin DLC cable (GHDM – 241000) to the OBD-II connector, located under the driver's side of the instrument panel.

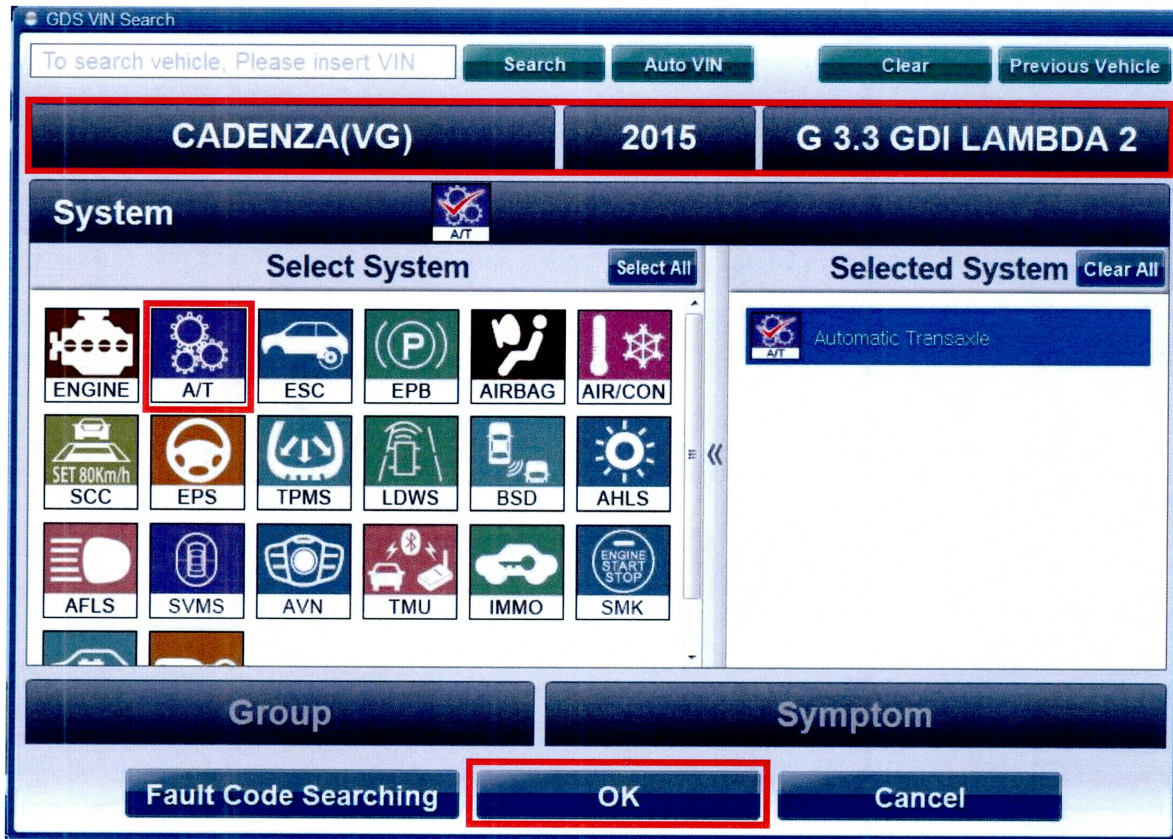
6. Once back at the GDS Main Screen, select ECU Upgrade from the bottom right-hand corner. Next select Auto Mode, and then EPS as the system. Perform the TCM upgrade in accordance with normal GDS TCM upgrade procedures.
