Service Bulletin

Subject: Difficult to Shift into Gear, Intermittent Gear Pop Out and/or Mushy Shifts (No Grind)

Models: 2014-2015 Chevrolet Corvette
Equipped with 7 Speed Manual Transmission (RPO MEL, MEP, MEK)

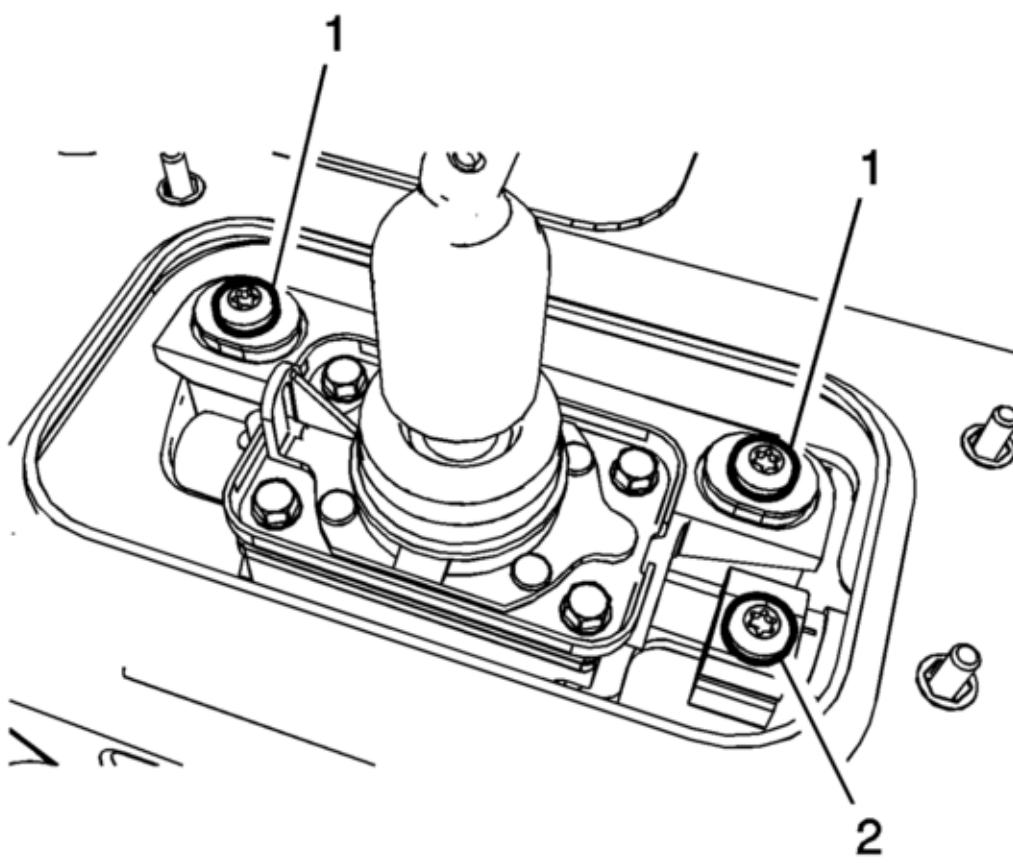
- 10.4.** Inspect for proper alignment in the Neutral position. When the shift rod clamp is properly positioned the bolt will engage the slot/relief in the shift rod and be positioned approximately 15 mm from the shifter assembly as shown above (1).
- 10.5.** Fix if incorrectly aligned by grabbing the linkage and push/pull to the proper gate.

10.6. Tighten the shift control mounting bolts (1) to 30 N•m (22 lb ft).

10.7. Tighten the transmission shift rod clamp bolt (2) to 30 N•m (22 lb ft).
