Diagnostic Trouble Codes (DTCs), Low Oil Pressure
CXU, GU, LEU, MRU
MP7 US2010, OBD2013, US2014, OBD2015

FSB 221-010, Diagnostic Trouble Codes (DTCs), Low Oil Pressure

(August 2015)

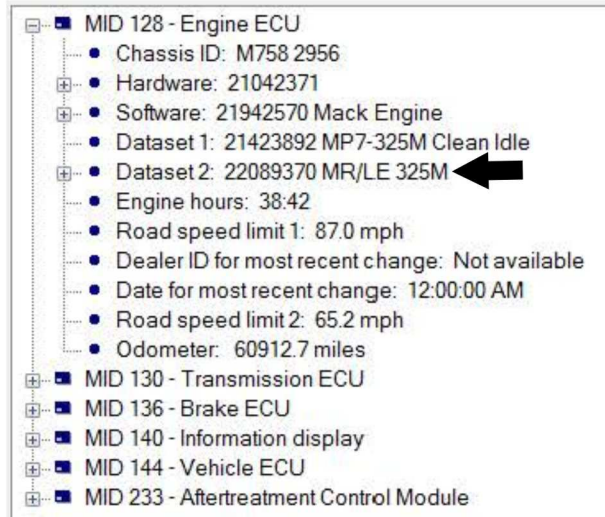
W2103598

US2010 and US2010 + 6 Control Unit Information

Data Set 2	US2010, January 1, 2010 to May 8, 2011	22494237 or less	Proceed with software update
		22709801 or higher	Open an eService and report the issue
	US2010 + 6, May 9, 2011 to December 31, 2012 (Includes LEU and MRU)	22488261 or less	Proceed with software update
		22711499 or higher	Open an eService and report the issue

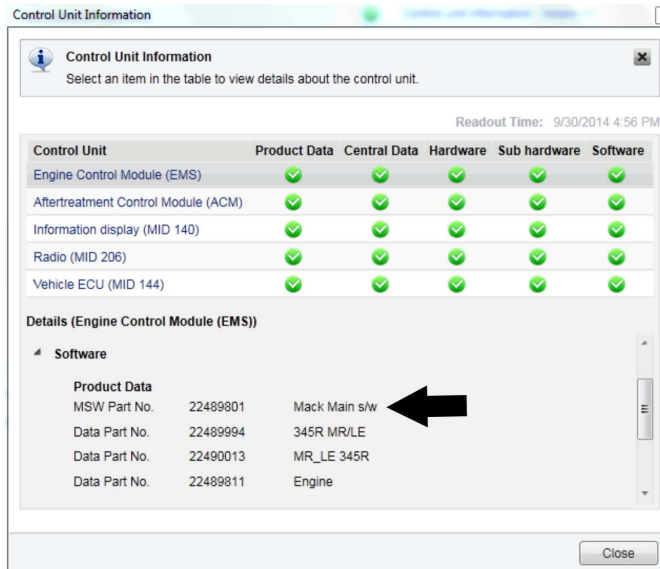
W2102733

OBD 2013, US2014 (GHG) and OBD2015 Control Unit Information
