GROUP BOD	MODEL 2016MY Sorento (UMa)
	NUMBER 114 (REV 1, 09/30/2015)	DATE September 2015
TECHNICAL SERVICE BULLETIN		
SUBJECT: SERVICE ACTION: SUNVISOR INSPECTION/REPLACEMENT (SA197)

SUBJECT: SERVICE ACTION: SUNVISOR INSPECTION/REPLACEMENT (SA197)

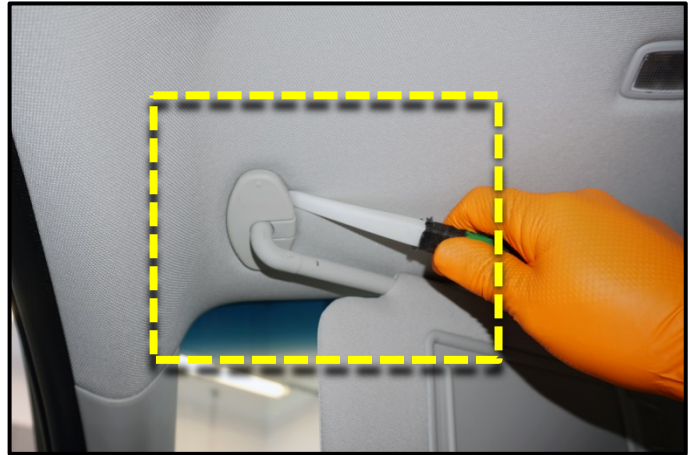
2. Remove two (2) screws securing the sunvisor in place.

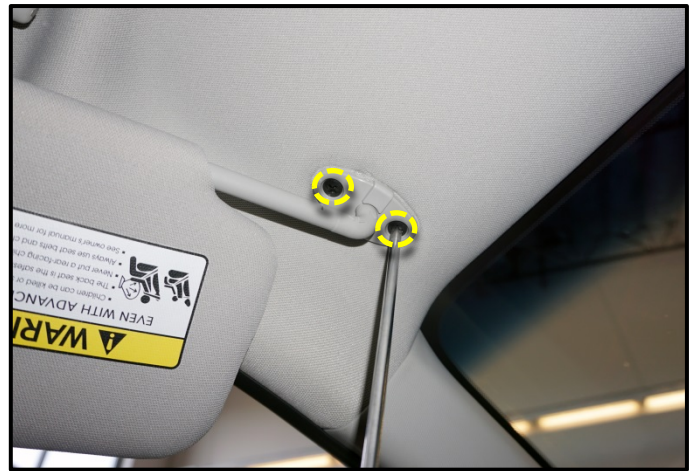
3. Gently pull the sunvisor harness through the access hole in the headliner and partially remove the fabric tape from around the connector.

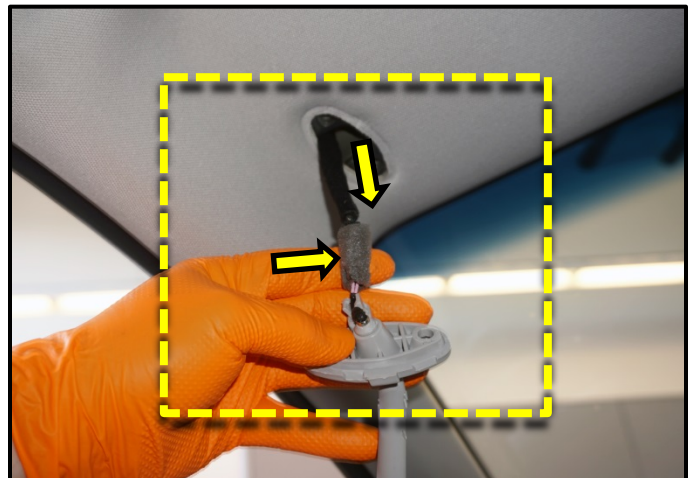
4. Use a pick tool to release the connection between the sunvisor and the rest of the harness.

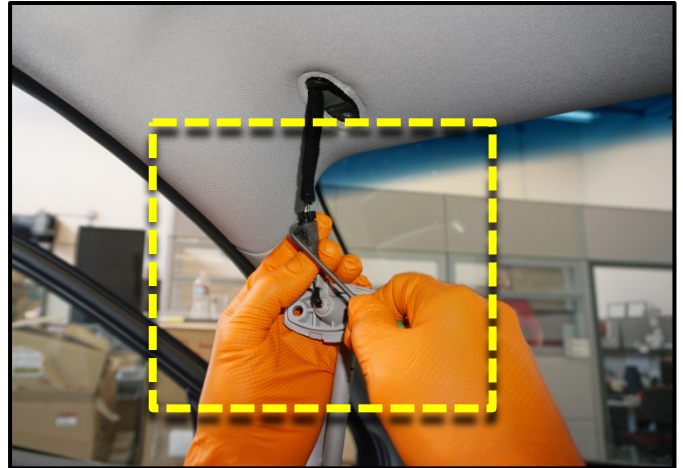
5. Place the sunvisor on a clean work surface, remove the harness from the holder and inspect it for exposed wiring. If the harness shows no visible signs of damage, proceed to step 6. If the harness shows visible signs of damage, proceed to step 7.
