GROUP Electrical	MODEL 2014MY Forte (YD)
	NUMBER 084	DATE May 2015
TECHNICAL SERVICE BULLETIN		
SUBJECT: SERVICE ACTION: UVO SYSTEM UPGRADE (SA 193)

SUBJECT: SERVICE ACTION: UVO SYSTEM UPGRADE (SA 193)

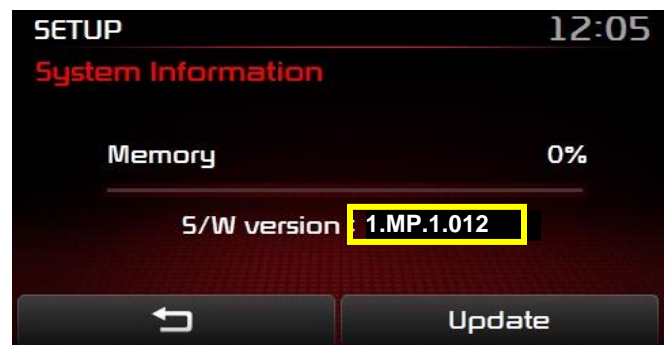
Original Software Version
1.MP.1.012

7. Check to ensure the original software version matches the information in the table below.

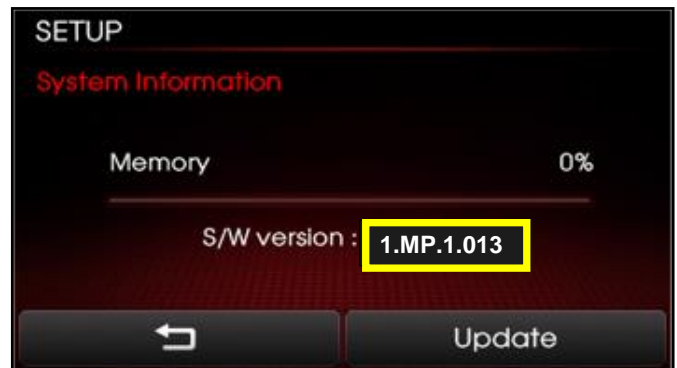
Final Software Version
1.MP.1.013

17. Check to ensure the final software version matches the information in the table below.
