Bulletin No.: 14665  
Date: July 2015

## CUSTOMER SATISFACTION PROGRAM

**SUBJECT:** Brake and Fuel Pipe Bracket Contacting Fuel Feed Pipe

**MODELS:** 2014 Chevrolet Caprice Police Patrol Vehicle (PPV)  
Equipped with 3.6L Engine (RPO LFX)

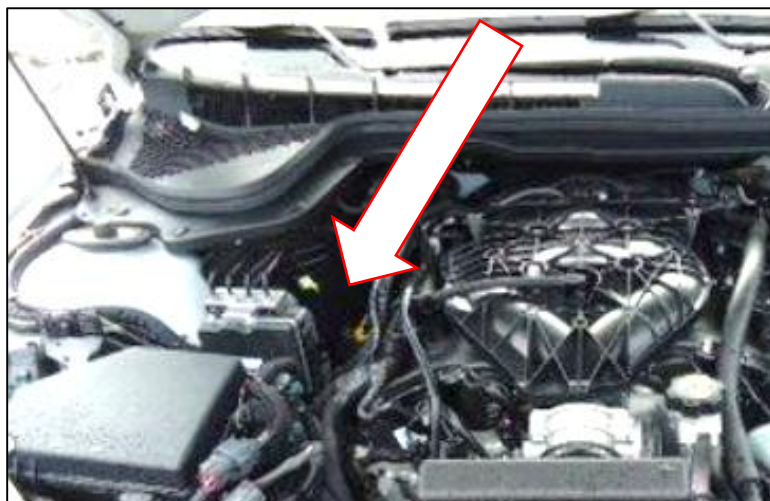
4225056

1. Open the hood and locate the brake and fuel line bundle on the passenger side of the engine bay just below the EBCM (Electronic Brake Control Module).

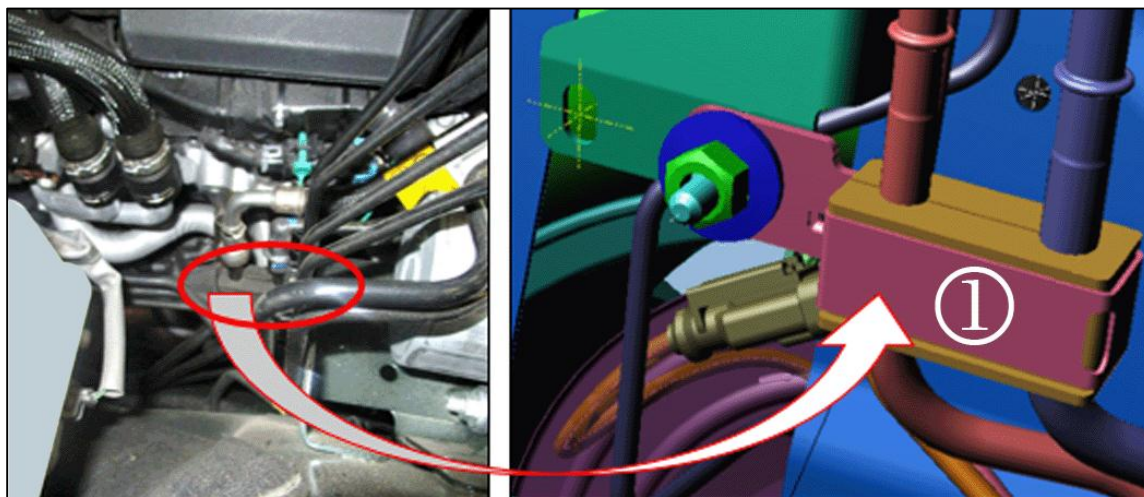
4225064

2. Identify the fuel line mounting bracket (1) located behind and below the EBCM.
