Program Bulletin

CUSTOMER SATISFACTION PROGRAM

SUBJECT: Navigation Radio Loss of Customer Settings

Subject: 13322B - Customer Satisfaction Program
Navigation Radio Loss of Customer Settings
Vehicles Involved and Service Procedure Revised

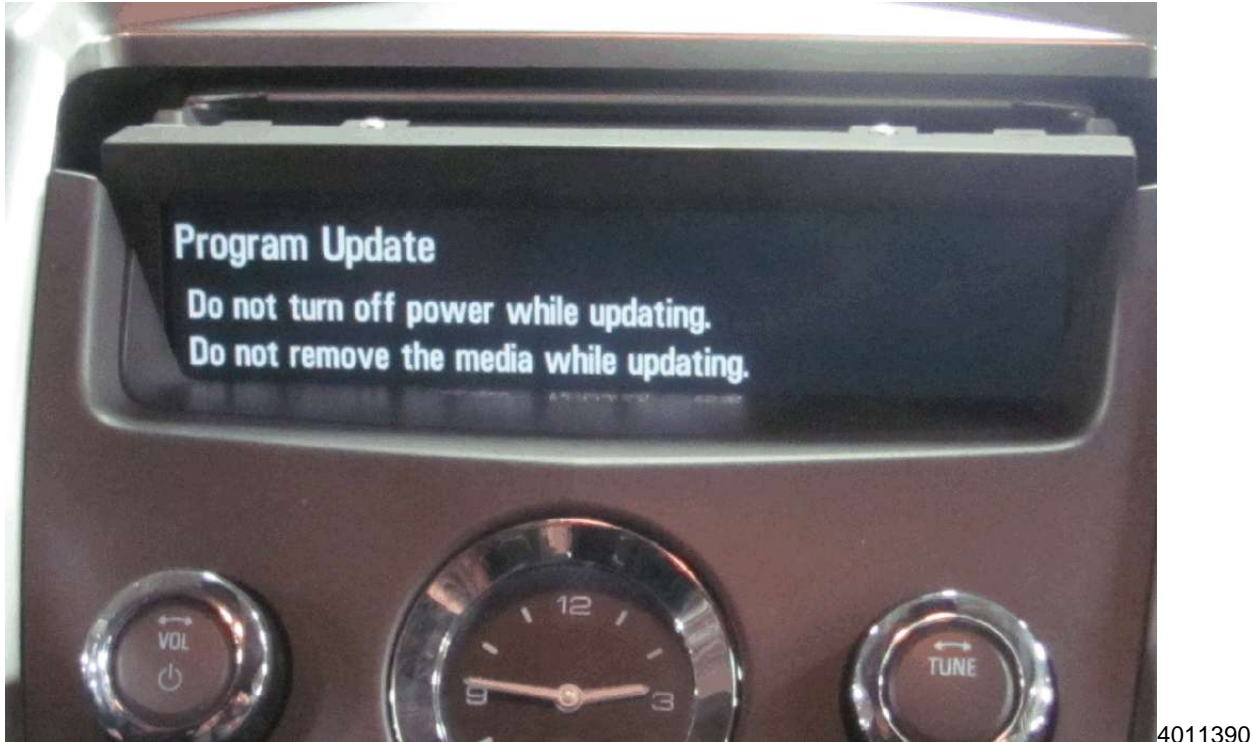
11. Insert the USB flash drive into the USB port of the vehicle. The radio will display the title “Program Update” along with warnings not to interrupt power or remove the media. A bar graph will form indicating progress and an “OK” button will appear. PRESS the appropriate radio button or area of the screen to activate the “OK” command and begin programming.

Note: Typically the programming event will take about 45 minutes to complete. The programming event may require more or less time to complete. Wait for the programming to complete BEFORE performing any action. The SRX viewscreen will lower and the program status bar will NOT be visible during programming. The partially raised viewscreen will be blank but have a white hue during programming. It is normal for the white hue progress bar to stay stationary for several minutes before it initially moves. Once the programming files have been transferred from the USB flash drive to the radio module, the SRX viewscreen will partially raise and display the following message: Program Update. Do not turn off power while updating. Do not remove the media while updating. Disregard the message on the screen.
