GM Bulletin No.: 14770  
Date: March 2015

**SUBJECT:** Service Update for Inventory and Customer Vehicles  
Seat Wire Harness  
Expires with Base Warranty

**MODELS:** 2014-2015 Chevrolet Impala

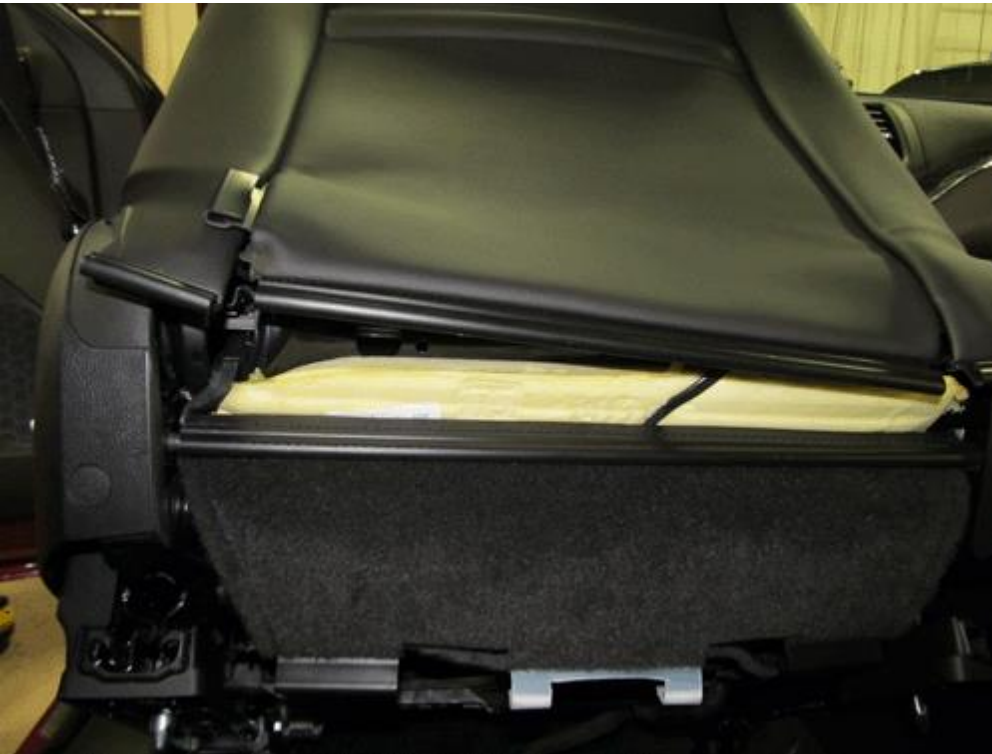
4001528

4. Disconnect the center section of the rear seat cover from the inboard and outboard cover. Raise the center section of the seat cover for inspection.
5. Inspect the wiring harness to seat back cushion pad wire clearance as shown.

3. Disengage the left seat back cover lower center and inboard J channel from the seat back frame.
