## SERVICE BULLETIN

**APPLICABILITY:** 2015MY Legacy and Outback Models

**NUMBER:** 12-177-14R

**SUBJECT:** Service Procedure to Address a Wind Rushing Sound from the Rear Door Sash Area

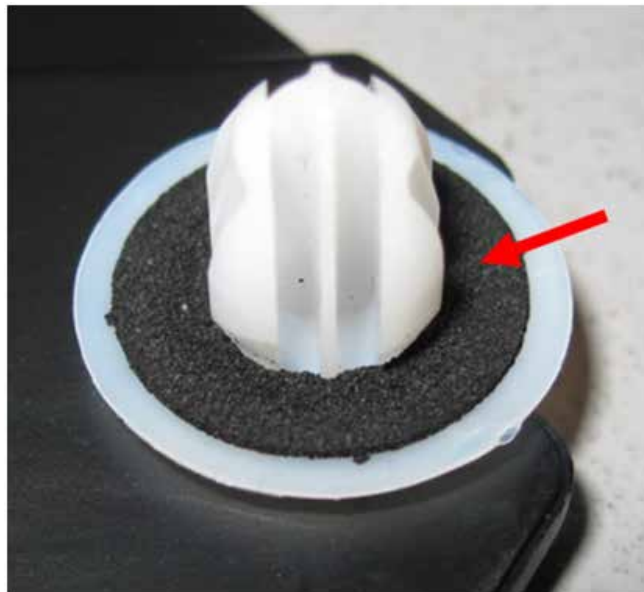
**NOTE:** Pay close attention to the small sealing gaskets used on the door trim. These gaskets must be in place as shown below before reassembly to properly seal their respective component and help eliminate the possibility of a rattling sound.
