SUBARU

SERVICE BULLETIN

APPLICABILITY: 2011-2014MY Forester Models with FB Engine

SUBJECT: Oil Seepage Diagnosis and Repair Procedures

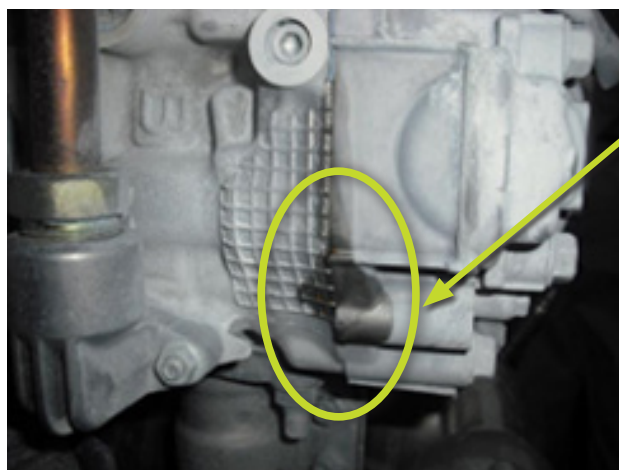
Cam carrier seepage seen from top left and lower right side of engine

If oil seepage is verified coming from between the cam carrier and the cylinder head as shown in the photos below, remove the cam carrier. Clean the machined sealing surfaces thoroughly and then re-seal using Liquid Gasket ThreeBond 1280B, (Part No. SOA5499100) or equivalent*. As shown in the photos below, the o-rings between the cam carrier and the cylinder head will need to be replaced as they are not re-usable. This would also be a good time to clean the Active Valve Control System (AVCS) filter screens which are contained in the cam carriers. **NOTE:** The filter screens are one-time use and must be replaced if they need to be removed. The replacement filter part# is 14451AA050.
