SERVICE BULLETIN

APPLICABILITY: 2015MY Legacy, Outback, Impreza & XV Crosstrek **NUMBER:** 15-182-15R
 2016MY WRX **DATE:** 06/17/15
 Models with Fujitsu-Ten (F10) Navigation System **REVISED:** 08/11/15

SUBJECT: Procedures for Updating the Head Unit Operating Software

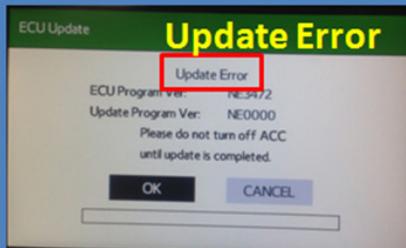
If "Update Error" screen is displayed as shown below:

Select "OK".

ACC OFF then back ON again

Perform the Version Update again from Step 3.
