## PRODUCT CAMPAIGN BULLETIN

**APPLICABILITY:** 2003-2004 Subaru Legacy and Outback  
 2003-2004 Subaru Baja  
 2004 Subaru Impreza  
 (including WRX and STI)

**NUMBER:** WQL-48R

**SUBJECT:** Front Passenger Air Bag Inflator Replacement

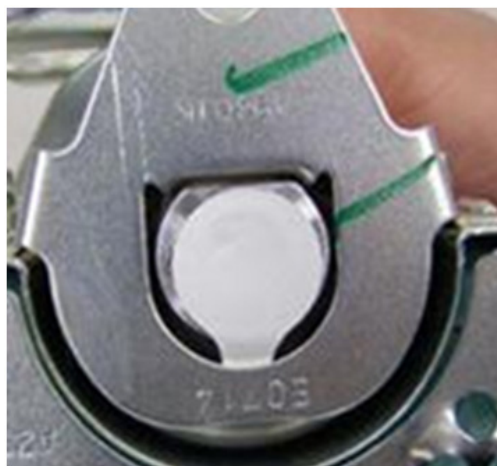
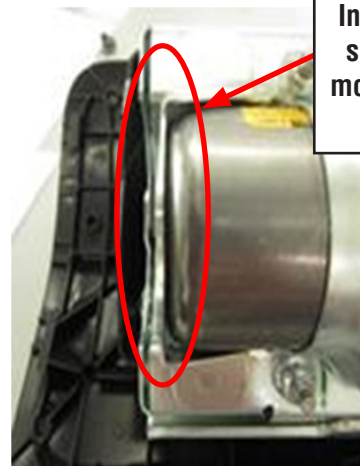
**Inflator properly seated against mounting bracket (NO GAP)**

**STEP 9-** Install the new inflator into the mounting bracket so the yellow taped end aligns with the removed stopper plate. Make sure the “D-shaped” portion of the inflator harness connector boss aligns with the “D-shaped” portion of the hole in the end of the mounting bracket as shown below. When properly installed, the end of the inflator will be seated tight against the mounting bracket. Do not peel the white harness connection dust cover at this time.
