SERVICE BULLETIN

APPLICABILITY: 2013-14MY Legacy and Outback Models with 2.5L FB Engines
 2011-14MY Forester Models with 2.5L FB Engines
 2015 MY Forester (Manual Transmissions Only) with 2.5L FB Engines
 2012-13 MY Impreza and XV Crosstrek Models with 2.0 FB Engines
 2014-15 MY Impreza and XV Crosstrek Models (Manual Transmissions Only) with 2.0 FB Engines

NUMBER: 02-157-14R
DATE: 08/28/14
REVISED: 12/07/15

SUBJECT: Surface Treatment Change To Oil Control Piston Rings

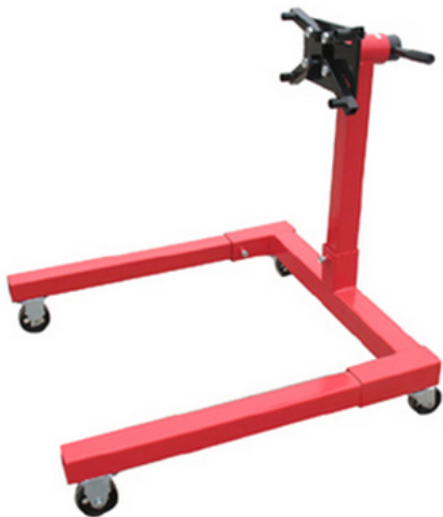
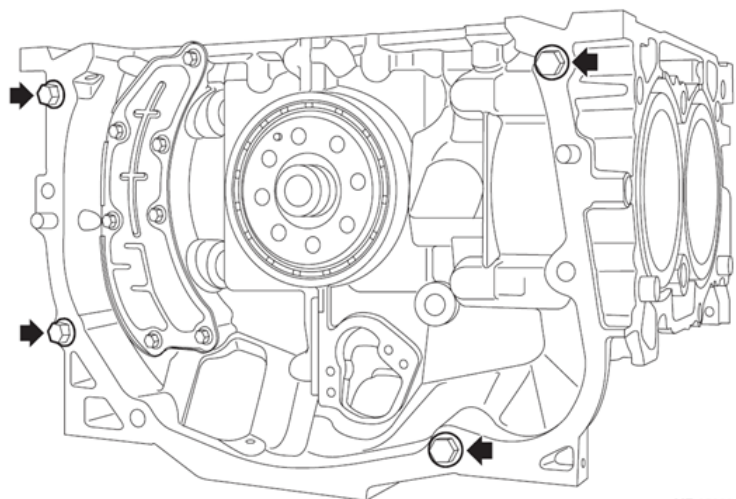
ME-05926

- Once the engine is removed, if you are using a generic engine stand (preferable since engine rotation is necessary), use the four mounting holes on the engine block shown below to mount it. **NOTE:** Do not use the mounting studs in the upper oil pan.

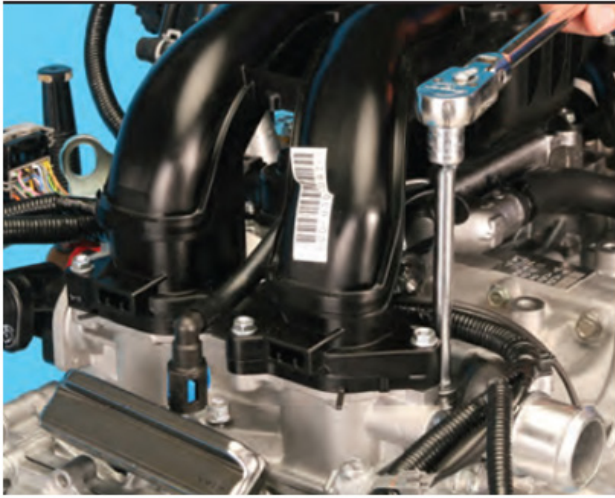
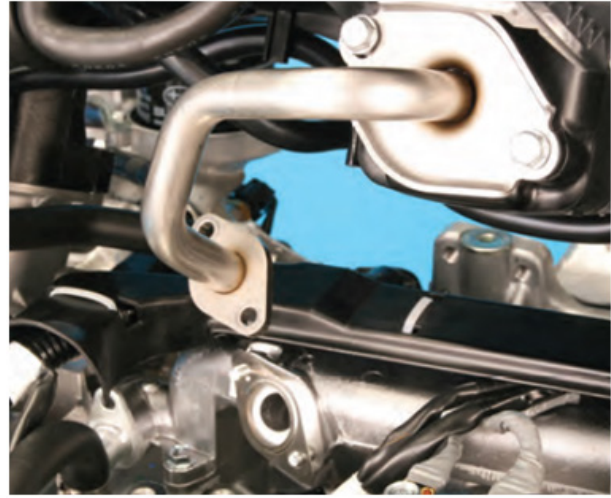
- When removing the intake manifold, as shown in the photos below, leave the TGV assemblies attached to the upper intake, remove the 2 nuts holding the EGR tube to the water pipe then remove the complete assembly from the cylinder heads as a unit.

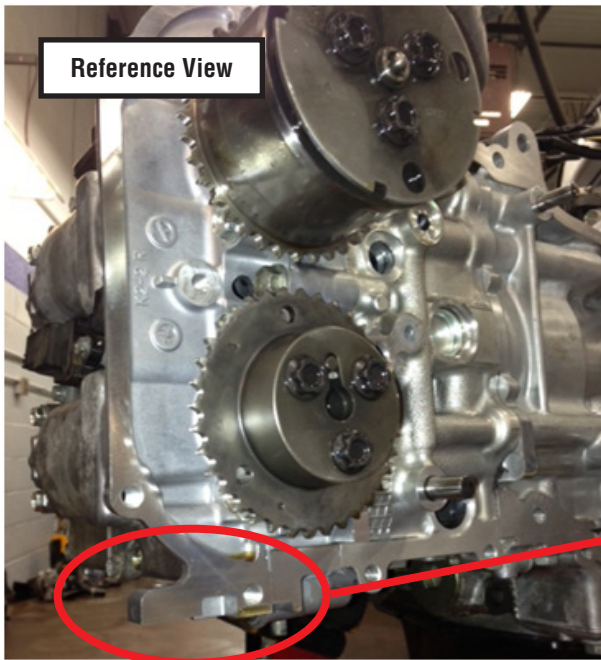
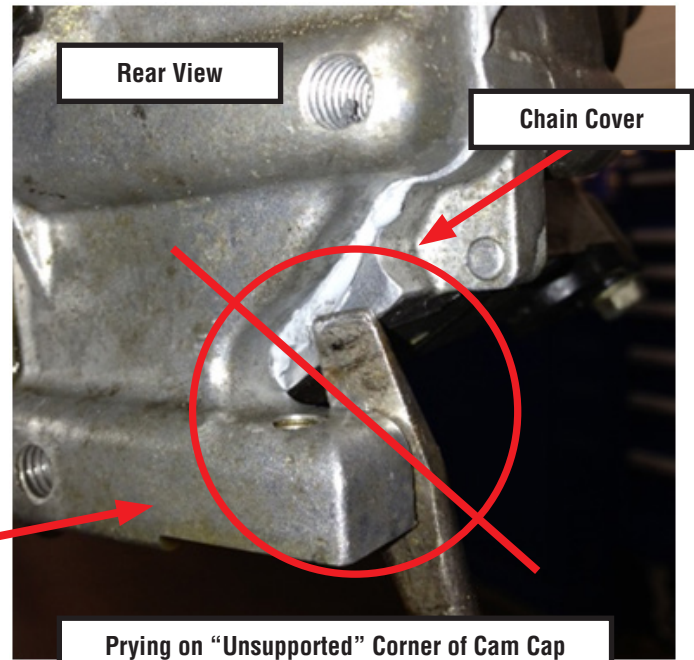
- There is no need to remove the oil dipstick tube or the original oil filter from the front chain cover. While the cover is removed, store it face (front side) down to minimize the chances of damaging the machined sealing surface on the block / head side. Also, don't use it as a tray to store other removed parts.
- **IMPORTANT:** After all 32 bolts securing the chain cover are removed, be **EXTREMELY** careful where you pry and what you pry on to break the silicone sealant's bond. The photos below show an example of where **NOT** to pry. In this case, the cam cap became cracked requiring a complete cam carrier replacement. *Patience is the key!*

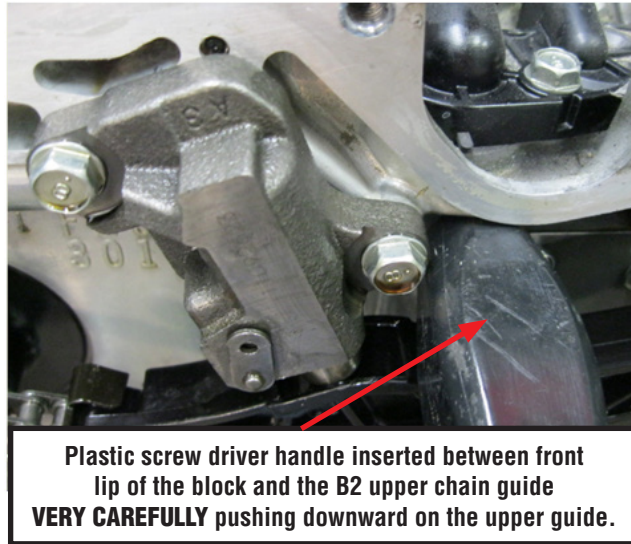
- If necessary, insert a plastic screwdriver handle between the lip of the block and the left side (B2) guide. Then, **VERY CAREFULLY** push down on the guide just enough to get the extra tensioner notch / “click”. When using this method, always make sure you are using plastic on plastic and NOT metal on plastic to avoid damaging the chain guides.
