© 2015 Mazda Motor of America, Inc.

Subject: UNUSUAL NOISE WHEN STARTING TO MOVE VEHICLE WHILE STEERING WHEEL IS TURNED TO FULL LEFT POSITION	Bulletin No: 06-001/15
	Last Issued: 07/21/2015

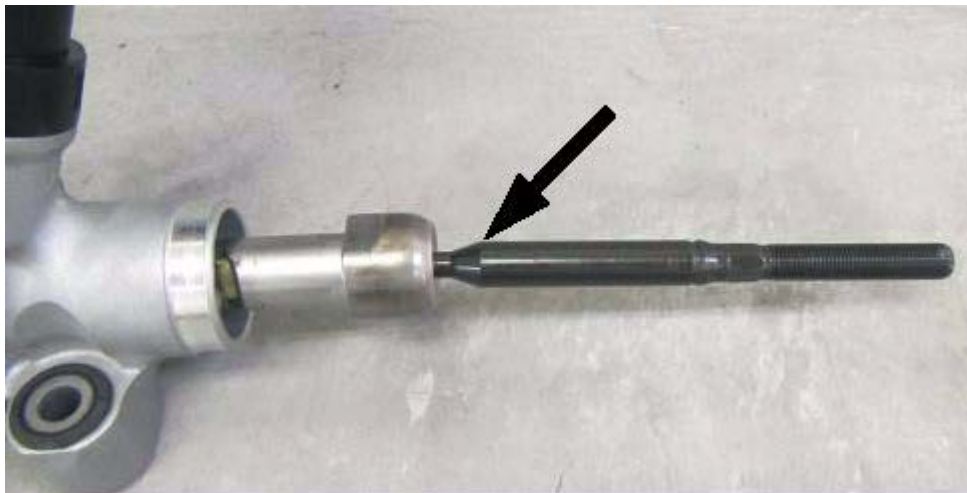
NOTE: The steering gear is shown below removed from the vehicle for illustrative purposes only. It is not necessary to remove the steering gear from the vehicle.

5. Remove the boot from the steering gear.
6. Lock the steering gear end (pinion gear side) with a suitable wrench to prevent rotation.

7. Remove the tie-rod.
8. Install a modified tie rod assembly to the steering gear.
Tightening Torque: 70 - 95 Nm {52 - 70 ft. lbf., 9.6 - 13 kgfm}
