| Reference | SSM72108 |
| Models | LR4 / L319 |
| Title | 2015 LR4 Instrument Cluster Message Center Display Concern |

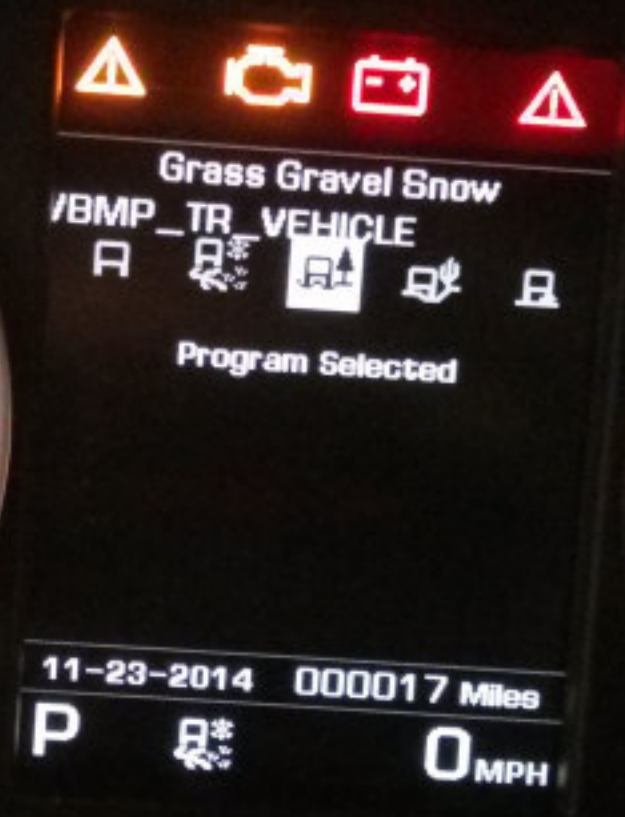
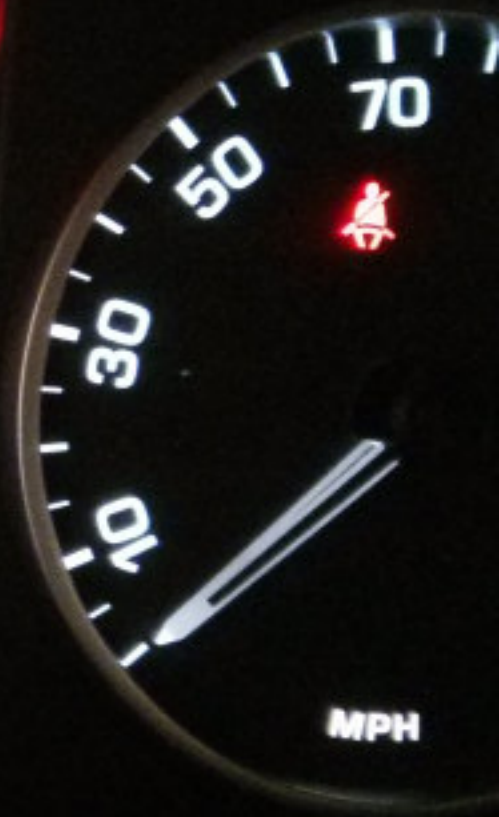
| Content | <p><b>***UPDATE***</b><br/><b><u>Instrument Cluster software, FH22-14C026-AD was released on DVD139, patch 17, calibration 200 to resolve this concern. This SSM will be removed once a bulletin is released to TOPIx.</u></b></p> <p><b><u>Model:</u></b><br/>2015 LR4</p> <p><b><u>Concern:</u></b><br/>A customer may state their Terrain Optimisation display in the Instrument Cluster Message Center does not correctly match the actual terrain mode which has been selected. Also the text in the Instrument Cluster Message Center, for the selected terrain mode, does not display correctly. "/BMP_TR_VEHICLE" is displayed instead of the correct corresponding text for the selected terrain mode.</p> <p><b><u>Cause:</u></b><br/>Instrument Cluster software fault for the "<i>English US</i>" language selection.</p> <p><b><u>Correction:</u></b><br/>New Instrument Cluster software is being developed and will be released as soon as possible. A further communication will announce the new software, when it becomes available.</p> <p>As an interim solution, the customer may select "<i>English UK</i>" from the Instrument Cluster display menu as follows:<br/><i>Main Menu &gt; Display Settings &gt; Language</i></p> <p>Until further notice it is recommended that the UK English language instrument cluster option is selected as a PDI default prior to vehicle delivery and that customers are advised to retain that language option to prevent display concerns.</p> <p><b>NOTE:</b> When the faulty message is shown, with "<i>English US</i>" selected, the improper display has no effect on the actual Terrain Response system. The Terrain Response switch displays the correct mode. There are no system performance related issues.</p> <p>For further clarification a photo has been attached showing the described concern.</p> |
