Subject: HOOD VIBRATION WHILE DRIVING AT HIGHWAY SPEED	Bulletin No: 09-019/15
	Last Issued: 05/19/2015

2013-2014 CX-5 vehicles with VINs lower than JM3KE*****387092 (produced before September 1, 2013)

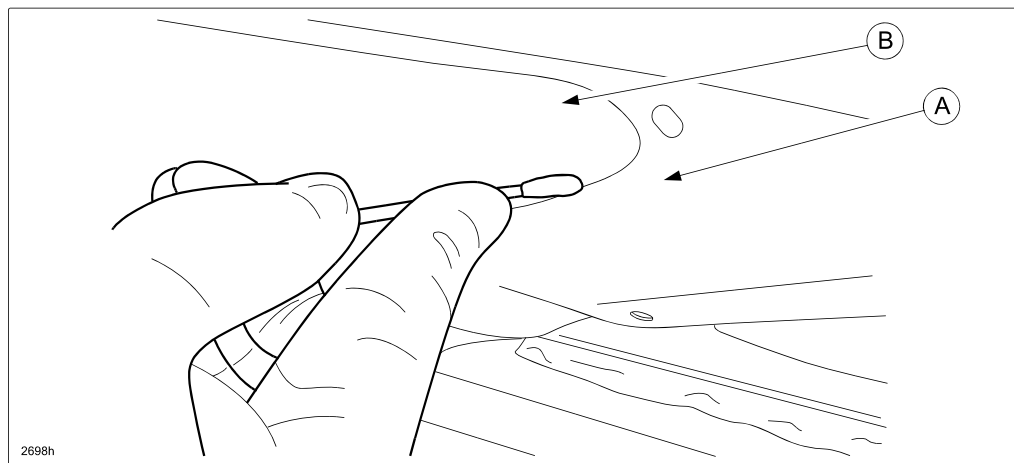
7. Using alcohol (of at least 50% content) and cotton swabs (or equivalent), thoroughly clean the fourteen (14) areas (shown below) between the hood's inner frame (A) and outer panel (B).

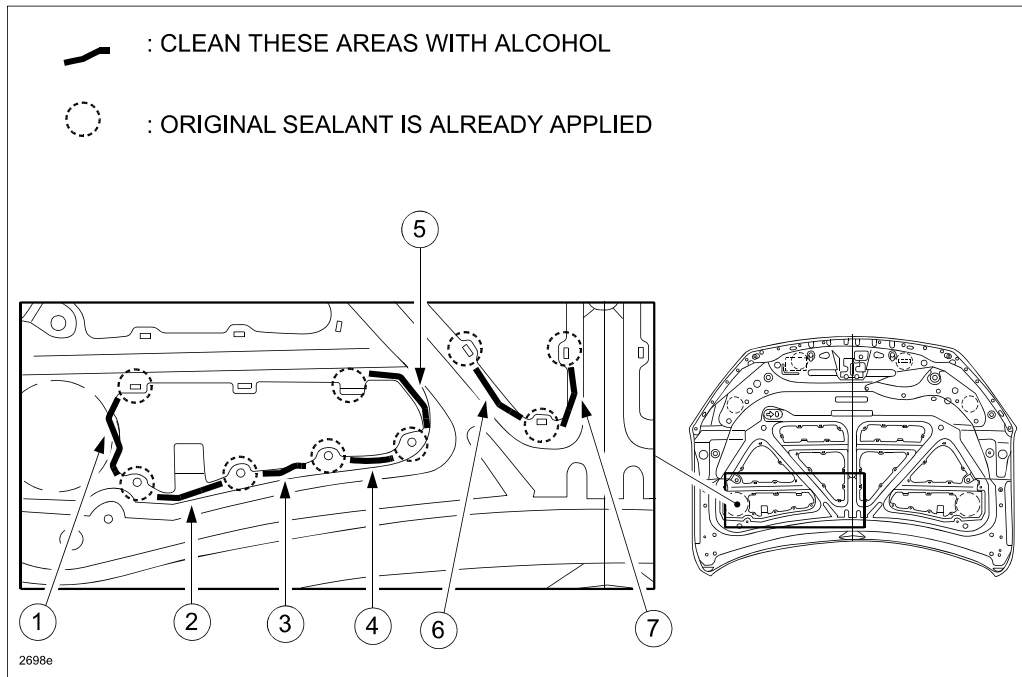
NOTE: There are seven (7) areas on the left side of the hood and seven (7) areas on the right side of the hood to be cleaned (left side shown below).
