<b>Subject:</b> <b>2013-2014 CX-5 - VARIOUS ELECTRICAL SYSTEM MALFUNCTION(S) RELATED TO C-15 CONNECTOR CORROSION</b>	<b>Bulletin No:</b> 09-041/15 <b>Last Issued:</b> 10/14/2015
---	---

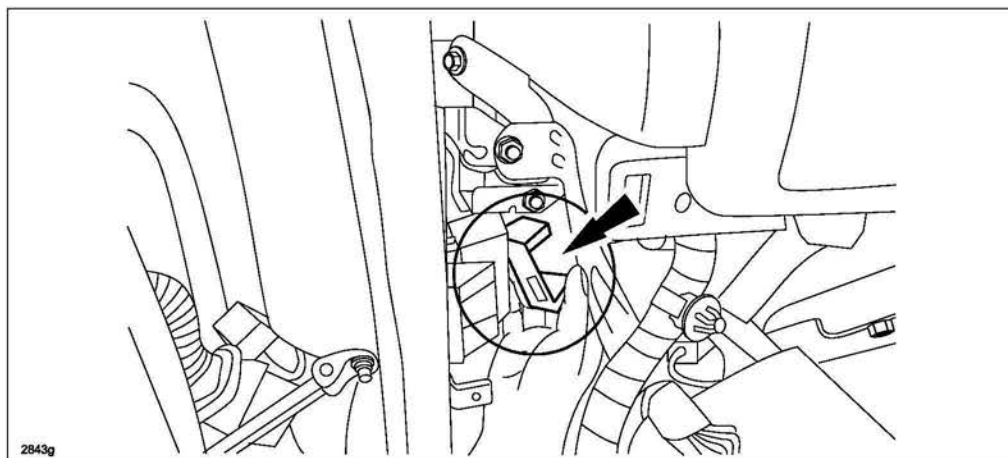
**CAUTION:** Use care not to swap the C-08 and C-15 connectors, otherwise, a no start condition could occur.

14. Using a small flathead screwdriver, push the tab of the C-08 connector bracket (A) in the direction of the arrows, then remove the C-08 connector bracket from the body.
