Subject: RUST ON UNDERCARRIAGE	Bulletin No: 00-004/15
	Last Issued: 11/17/2015

2015 Mazda3 (Mexico built) vehicles with VINs starting with 3MZ (see attached VIN list)

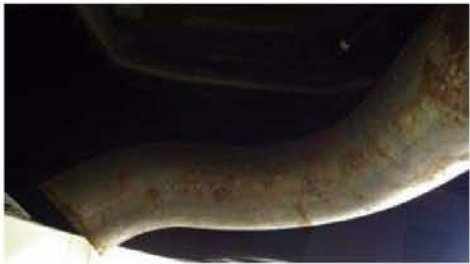
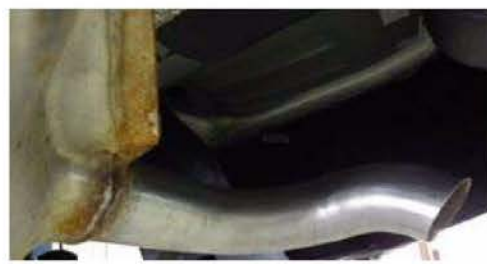
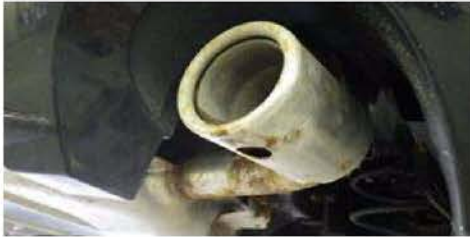
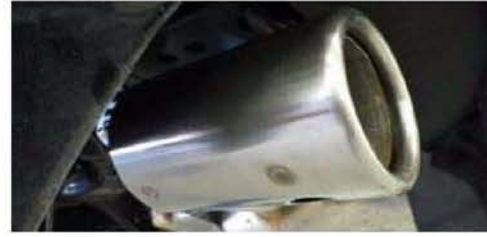
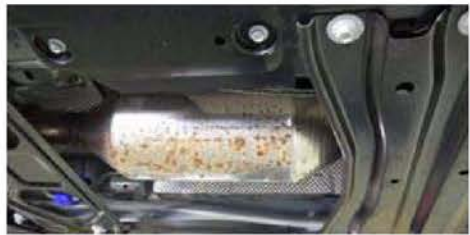
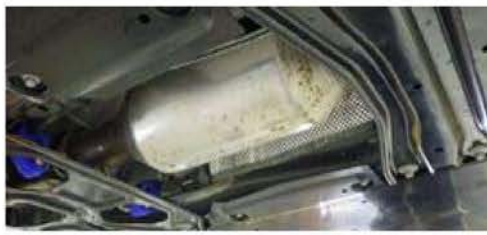
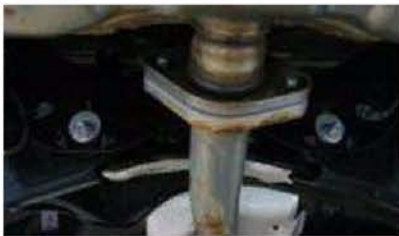
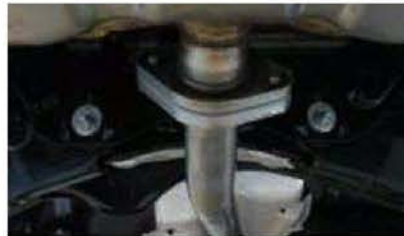
Some vehicles that were held in Port Veracruz may exhibit surface rust on the undercarriage. Port Veracruz is at the southern part of Mexico, facing the Gulf of Mexico. This area is known for very harsh environmental conditions such as extremely hot conditions, acid rain, strong winds and heavy rainfall. The combination of these natural elements can result in surface rust to the exterior chrome moldings and metal undercarriage components.

1. Verify customer concern and confirm that customer's vehicle is on the attached VIN list.
2. Raise vehicle completely in air to clean and seal undercarriage
3. Using a semi-rough scrub pad, remove any surface rust/rust from the entire (top, bottom and sides) exhaust system. Wipe the exhaust with clean paper towel. If the vehicle is equipped with chrome exhaust tip(s), use a soft/fine scrub pad and remove the rust from them. Using the same pad, clean any rust from inside the exhaust tip. Using a large wire brush, clean the flange between the rear silencer and the front exhaust pipe.

NOTE: DO NOT use Rust Fix on the exhaust system.
