May 13, 2015

01621 Version 1

AcuraLink[®] System Status Indicator Is Red and DTC B1403 Will Not Clear

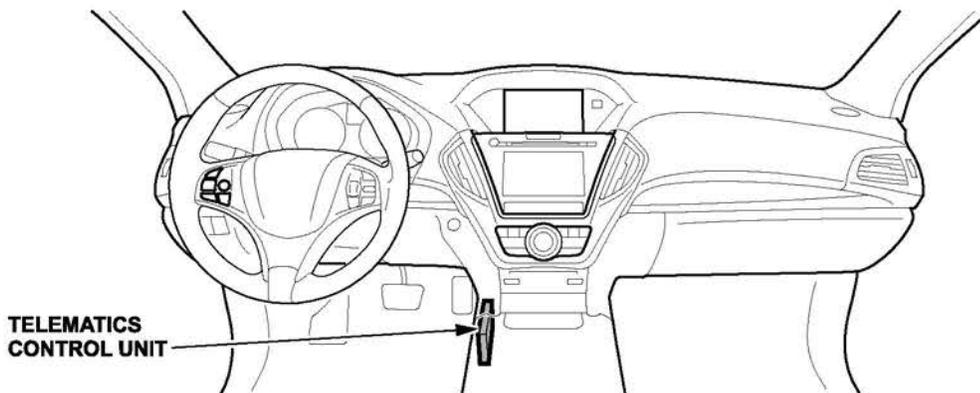
1. Find the TCU. It is behind the center console side cover on the driver's side. See the electronic service manual for details.

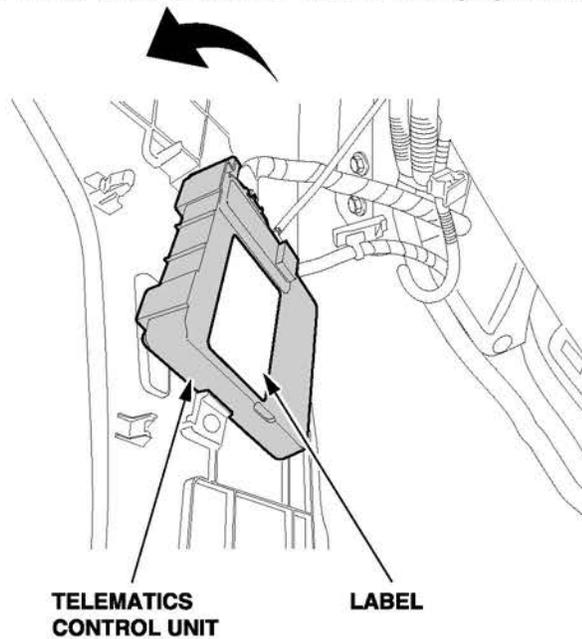
2. Pull the cover to the side without damaging the harness and connectors so that you can access the TCU label.

3. Check the label for the latest Visteon part revision number.
 - If the Visteon part revision number is 13 or above and the software revision number is 02.07.000 or above, the TCU is okay and this bulletin does not apply. Continue with normal troubleshooting.
 - If the Visteon part revision number is 12 or less and/or the software revision number is 02.06.000 or less, replace the TCU and go to step 4.

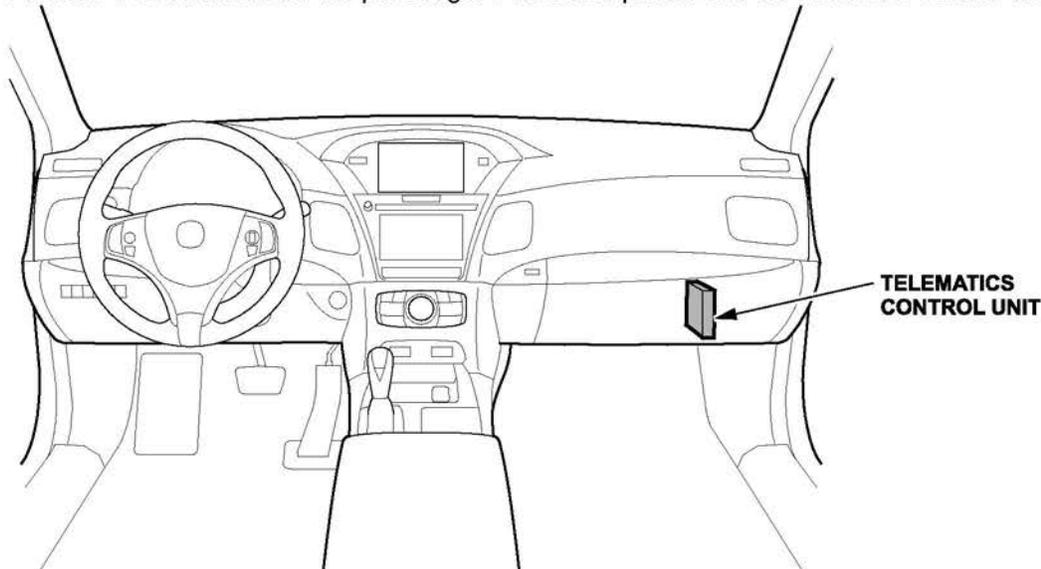
1. Find the TCU. It is behind the passenger's side kick panel. See the electronic service manual for details.

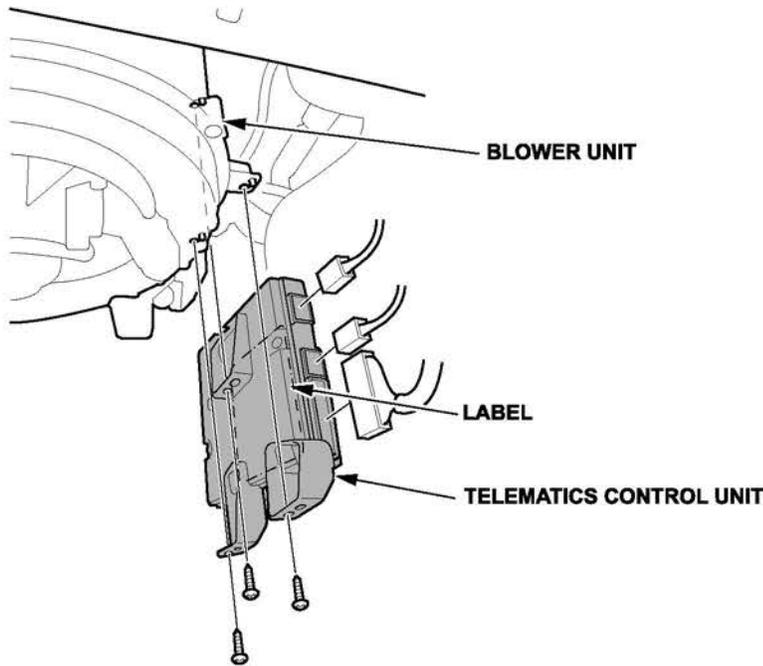
- Remove the screws and disconnect the connectors.

- Check the label for the latest Visteon part revision number.
 - If the Visteon part revision number is 13 or above and the software revision number is 02.07.000 or above, the TCU is okay and this bulletin does not apply. Continue with normal troubleshooting.
 - If the Visteon part revision number is 12 or less and/or the software revision number is 02.06.000 or less, replace the TCU and go to step 4.

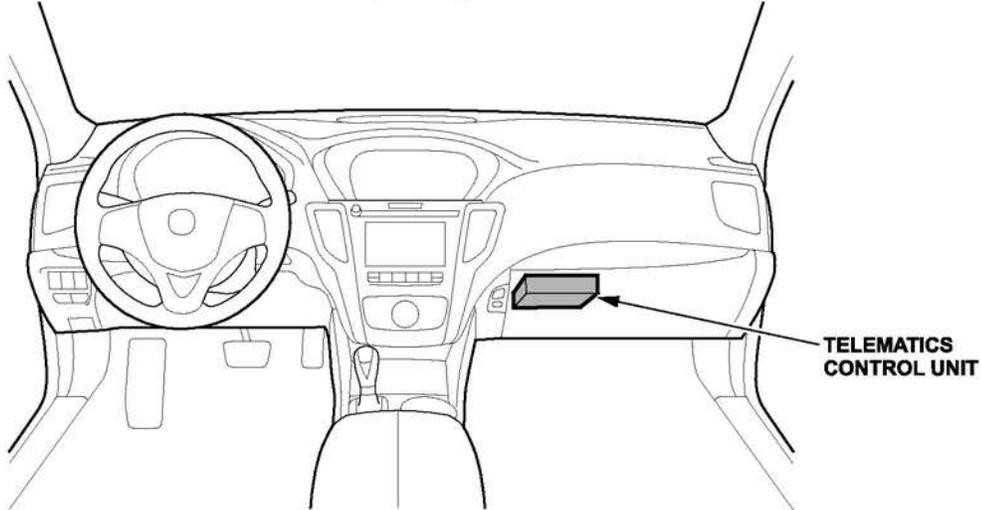
1. Find the TCU. It is behind the passenger's dashboard undercover. See the electronic service manual for details.

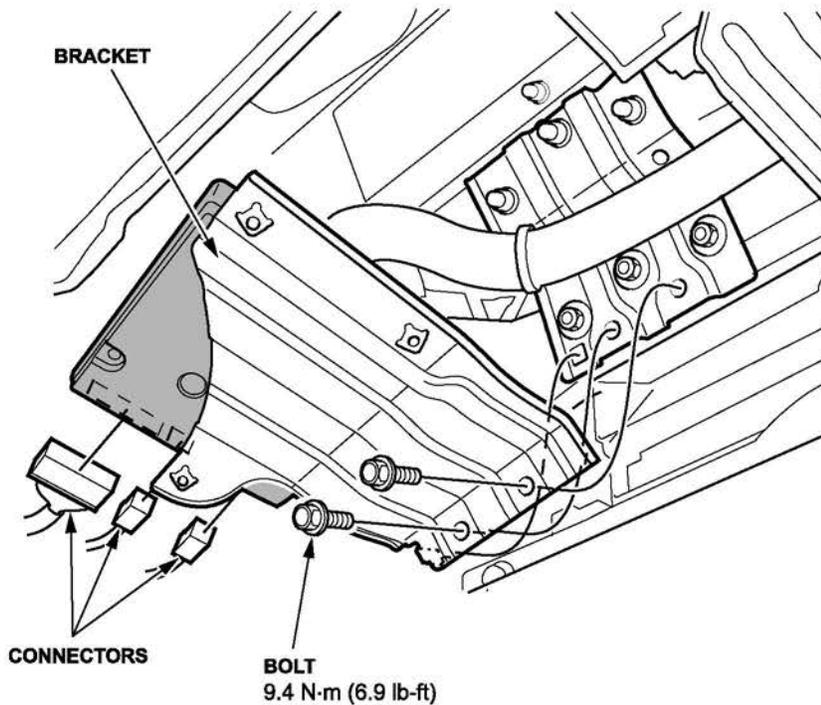
2. Remove the two bolts, then remove the bracket and disconnect the connectors.

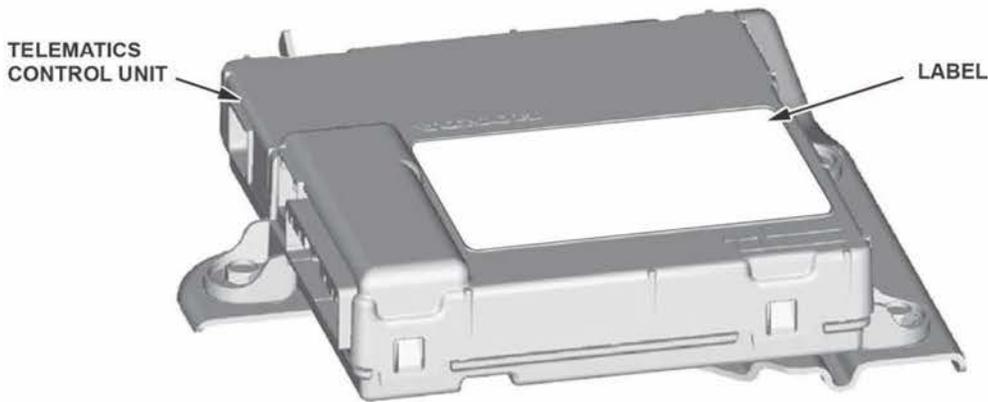
3. Locate the TCU label.

4. Check the label for the latest Visteon part revision number.
 - If the Visteon part revision number is 11 or above and the software revision level is 01.05.000 or above, the TCU is okay and this bulletin does not apply. Continue with normal troubleshooting.
 - If the Visteon part revision number is 10 or less and/or the software revision number is 01.04.000 or less, replace the TCU and go to step 5.
