Technical Service Bulletin TS 04 92916

Driveshaft Flange and Oil Seal for Spare Parts Supply

Affected Models: All 4WD SX4 (RW420) Models

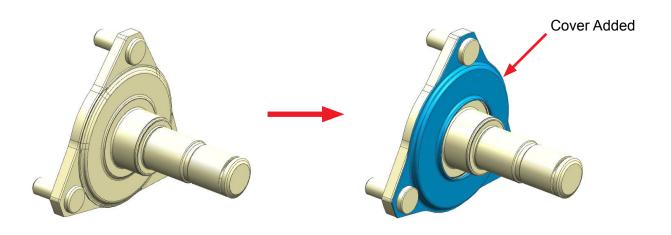
Flange Comp, Driveshaft EARLY PART

Flange Comp, Driveshaft NEW PART

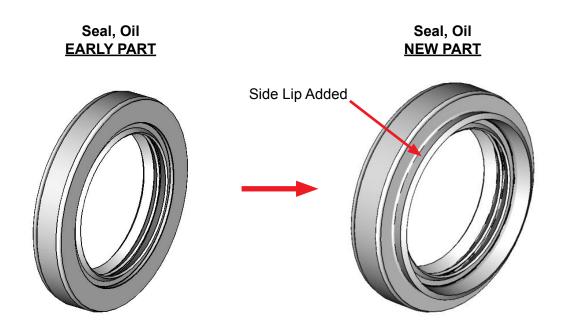
If visual inspection reveals corrosion on the driveshaft flange as shown here, the oil seal lip might be damaged.

Replace both the driveshaft flange and oil seal with the new parts listed in this Technical Service Bulletin.
