iNformation

MSN 15742 (1602)

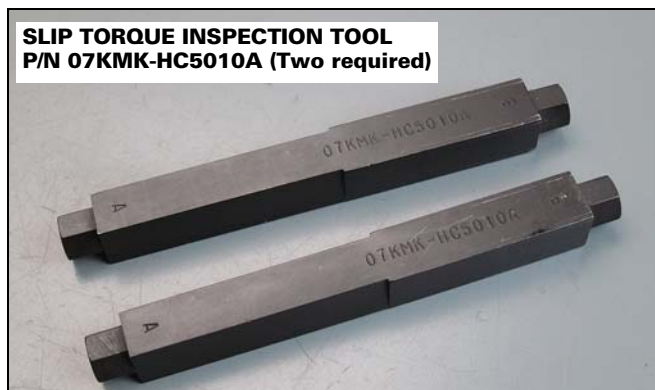
Checking the differential slip torque allows you to assess the condition of the differential without having to disassemble it. However, the tool depicted in the *Differential Inspection* section of the Service Manual is not available from American Honda. The tool that is available in the U.S. (P/N 07KMK-HC5010A), looks like an almost square bar of steel that couldn't possibly fit into the female splines of the front drive unit. Yet it does as the trapezoid shape perfectly engages the female splines within the front differential.

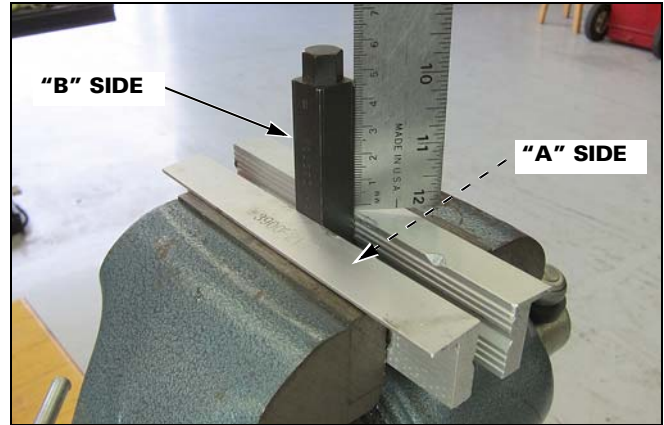
1. Choose the side of the tool that best fits the differential splines; "A" side is smaller than "B" side. In this example the "B" side fits the TRX420/500 differential shown here.
2. Clamp the parallel edges of the "A" side of the tool in a bench vise so that the "B" side sticks up about 60 mm as shown.

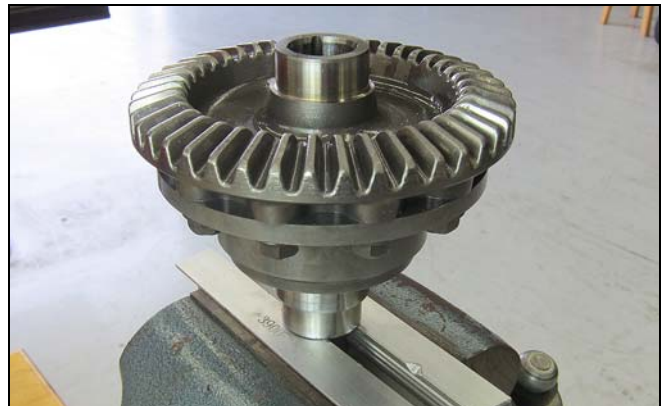
3. Install the differential assembly onto the "B" side of the tool as shown.

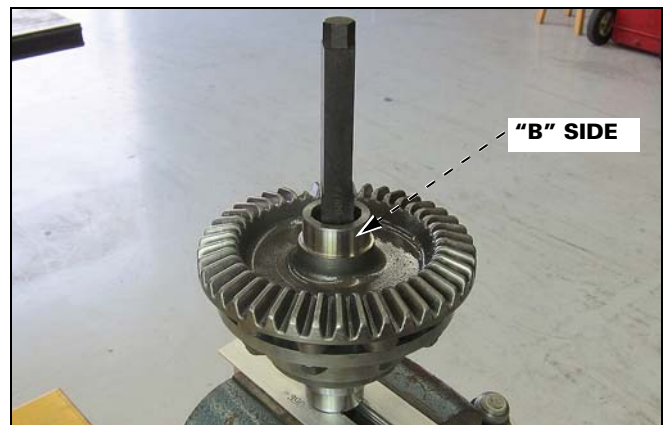
4. Install the "B" side of the second tool into the other side of the differential as shown.

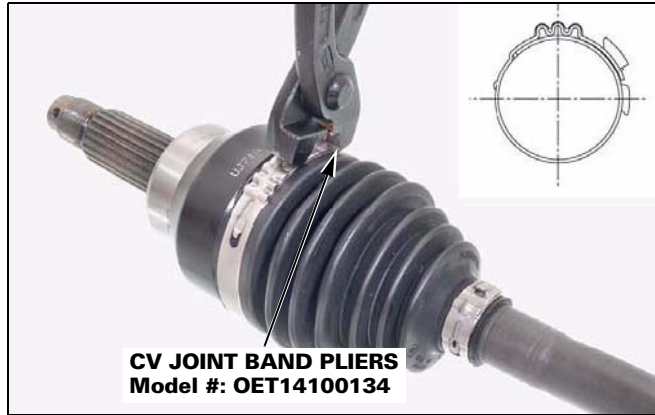
Starting with model year 2015, several TRX and all SXS models feature new super tough plastic CV joint boots on the drive shafts. The removal and installation of these new boots is easier than with previous designs, but requires new CV joint band pliers to install the boot bands. Be sure to refer to the Service Manual when servicing the CV joints on late-model TRX and SXS as each joint requires a unique boot and band combination. Also, the Service Manual outlines the correct installation

direction for the boot bands as well as the technique for using the boot band tool.

Make sure your service department is properly equipped. Order the new boot band pliers from the Honda Tool and Equipment Program by logging on to **iN** and following this path:
