Vehicle Technical Info

GROUP 00 – General

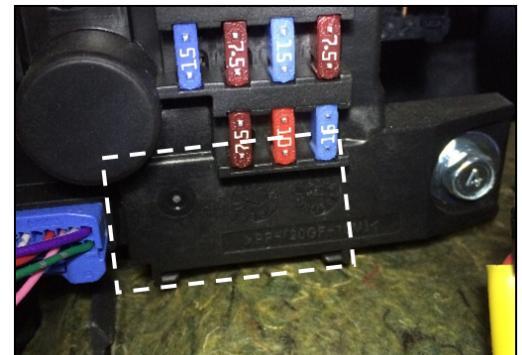
Stamped P/N (select "Can't see P/N")

- 3. ETACS identification in the Loading Option Setup box is required when working on the following vehicle systems. Select "Can't see P/N" or "Can see P/N" before proceeding.
 - ETACs replacement and coding
 - TPMS registration
 - KEYLESS registration
 - LIN system diagnosis
