DENSO Driving Assist & Safety Eng. Div.3
Driving Assist & Safety Quality Assurance Div.

Title Filed claim investigation result for Airbag sensor (DRAS II)

Part Name : SENSOR, AIR BAG, FR

Part Number : 89173-06120

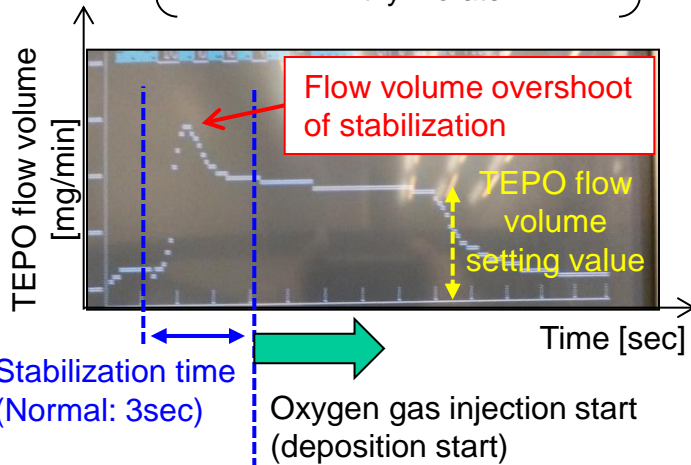
Gas injection setting profile

<Occurrence cause: Flow volume profile change>

| Cause | Countermeasure (1) |
|---|--|
| <p>- Machine error occurred because of TEPO flow volume variation. Maintenance engineer changed the flow volume profile in order to control the variation. (Changed to an overshoot waveform to make the flow volume stable early.) * At this moment, no knowledge that overshoot causes local concentration increase.</p> <p>➔ At the time of deposition start, P concentration in chamber (shadowed area below) increased, and P concentration of interface between BPTEOS and PEN films (soon after deposition start) increased.</p> <div data-bbox="120 668 1036 1199"> <p><Before change> <After change></p> <p>TEPO flow volume</p> <p>Time [sec]</p> <p>Stabilization time (3sec)</p> <p>Deposition start (Oxygen gas injection)</p> <p>SIMS value [wt%]</p> <p>Depth [nm]</p> <p>Local P concentration increase</p> </div> | <p>- Changed the flow volume profile not to overshoot. ('14/12/17~)</p> <div data-bbox="1065 478 2028 835"> <p><Before countermeasure> <After countermeasure></p> <p>TEPO flow volume</p> <p>Setting value</p> <p>3sec</p> <p>3sec</p> </div> |
