Service Bulletin

Subject: Information on Vibration Analysis and Diagnostic

Models: 2014 Chevrolet Silverado 1500
 2015-2016 Chevrolet Silverado
 2014 GMC Sierra 1500
 2015-2016 GMC Sierra

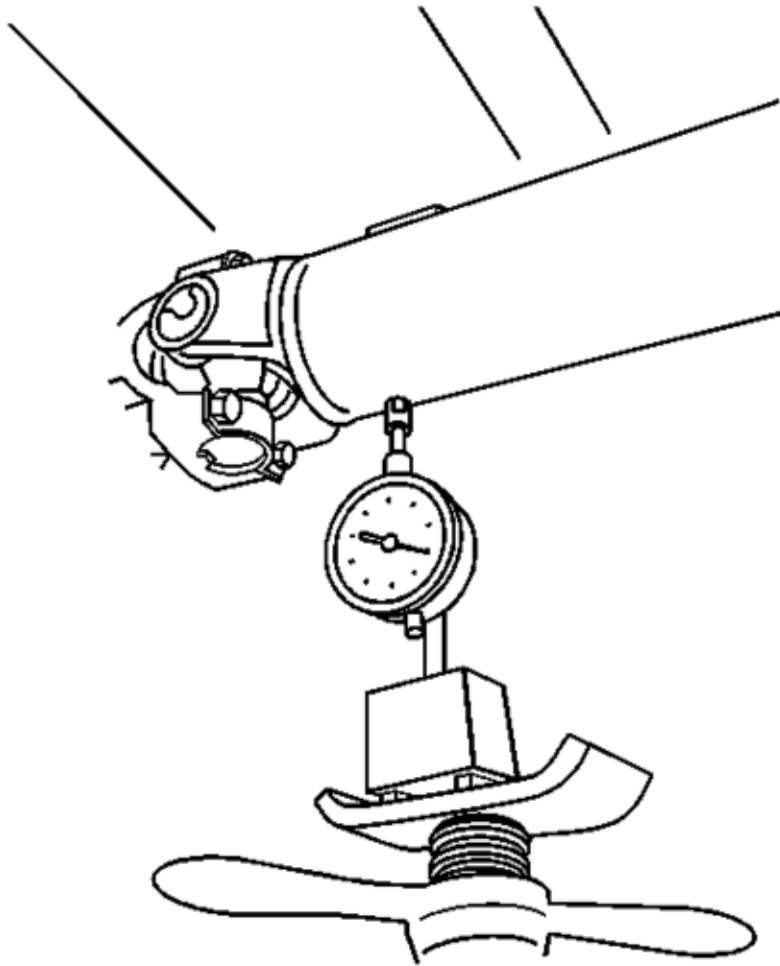
- This measurement procedure is intended to measure propeller shaft runout for prop shaft systems with 2 or 3 U-joints only. This is not for prop systems with only 1 U-joint, or with only constant velocity (CV) joints, and/or coupler assemblies.
- When measuring runout of propeller shafts, do not include fluctuations on the dial indicator due to welds or surface irregularities.
 1. Raise and support the vehicle with the wheels free to rotate. Refer to the Lifting and Jacking the Vehicle in SI.
 2. Place the transmission in NEUTRAL.
 3. Clean the circumference of the propeller shaft of any debris and/or undercoating along the rear of the shaft, where contact of the dial indicator will make to the propeller shaft.
 4. Inspect the propeller shaft for dents, damage, and/or missing weights. Any propeller shaft this is dented or damaged requires replacement.

5. Mount the GE-7872 Magnetic Base Dial Indicator Set, or equivalent, or the GE-8001 Dial Indicator Set, or equivalent, to the vehicle underbody or to a service stand positioned just clear of the U-joint yoke weld on the prop shaft.

6. Rotate the drive pinion axle flange, torque tube input flange, transmission output, or transfer case output flange by hand while take runout measurements of the prop shaft. The prop shaft will rotate more easily in one direction than in the other. If necessary, the tire and wheel assemblies and even the brake caliper assemblies can be positioned and supported aside, or the brake drums can be removed from the drive axle to provide axle to provide easier rotation of the prop shaft.

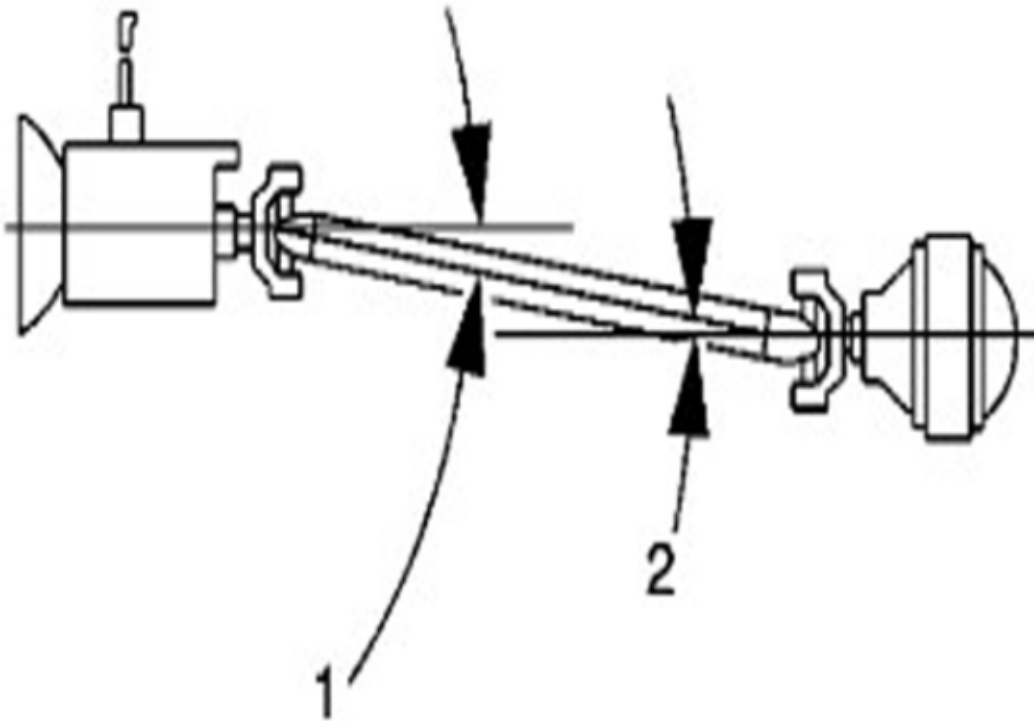
Measurement	Notes:
Yoke to Shaft		The first (forward most) U-joint action on a two piece driveshaft system is not canceled out by another U-joint. Because of this, the first U-joint working angle should be between 0.5 and 0.75 degrees.
Front Shaft to Center Support Bearing (if equip)		U-joint pairs cancel each other. Neither U-joint working angle should exceed 4 degrees, nor the allowable range of difference between cancelling U-joint working angles is 0.00 to 1.0 degrees.
Shaft to Diff Yoke

Propeller systems containing only 1 U-joint: The U-joint working angle should be between 1/2 and 3/4 degrees.

Allowable range of difference between cancelling U-joint working angles: 0.25 to 1.0 degrees.

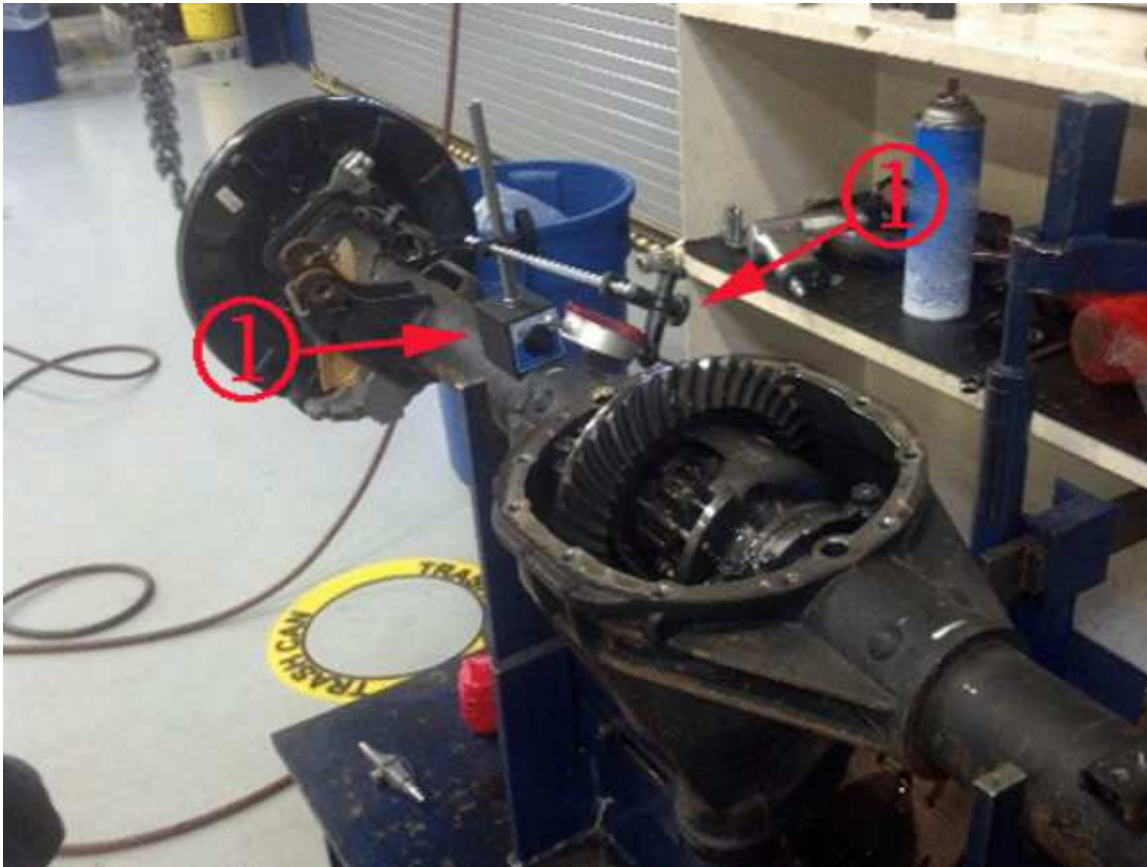
Note: The illustration above is for reference only. The differential does NOT need to be removed from the vehicle.

3. Set the J-8001-3 indicator (1) so that the stem is aligned with the gear rotation (1) and square to the tooth angle.
4. Hold the drive pinion stationary and move the ring gear back and forth.
5. Repeat the measuring procedure at **each tooth** around the ring gear.
6. The difference between the backlash at all of the measuring points should not vary by more than 0.05mm (0.002 in).
7. If the difference between the backlash at all of the measuring points varies by more than 0.05 mm (0.002 in), inspect for burrs, a distorted case flange or uneven bolting.
8. If the difference between all the measuring points is within specifications, the backlash at the minimum lash point measured should be 0.08-0.25mm (0.003-0.010 in) with a preferred backlash of 0.13-0.18 mm (0.005-0.007 in).

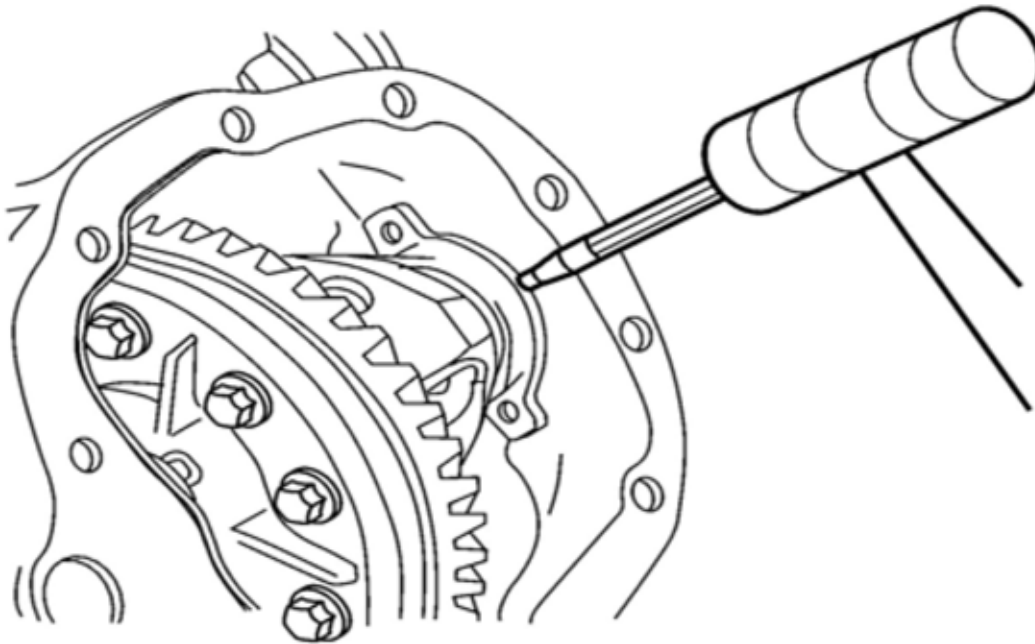
Note: The service spacers must be installed between the service shim(s) and the axle housing.

12. Install the differential case assembly with the bearing cups.
13. Install the left side service shims between the axle housing and the differential case.
14. Install the right side service shims between the axle housing and the differential case.

15. Using the brass drift for 9.5/9.76 axle, install the left side service spacer.
16. Recheck the backlash and adjust, if necessary.
17. Install the bearing caps and bolts and tighten to 85 N•m (63 lb ft).
18. Recheck the backlash and adjust, if necessary.
19. Once backlash is correct, perform a gear tooth contact pattern check in order to ensure proper alignment between the ring and pinion gears. Refer to the Gear Tooth Contact Pattern Inspection in SI.
