### SSM 72313 - L405 & L494 Fuel Filling Difficulties

# L405 & L494 Range Rover & Range Rover Sport Fuel Filling Concerns

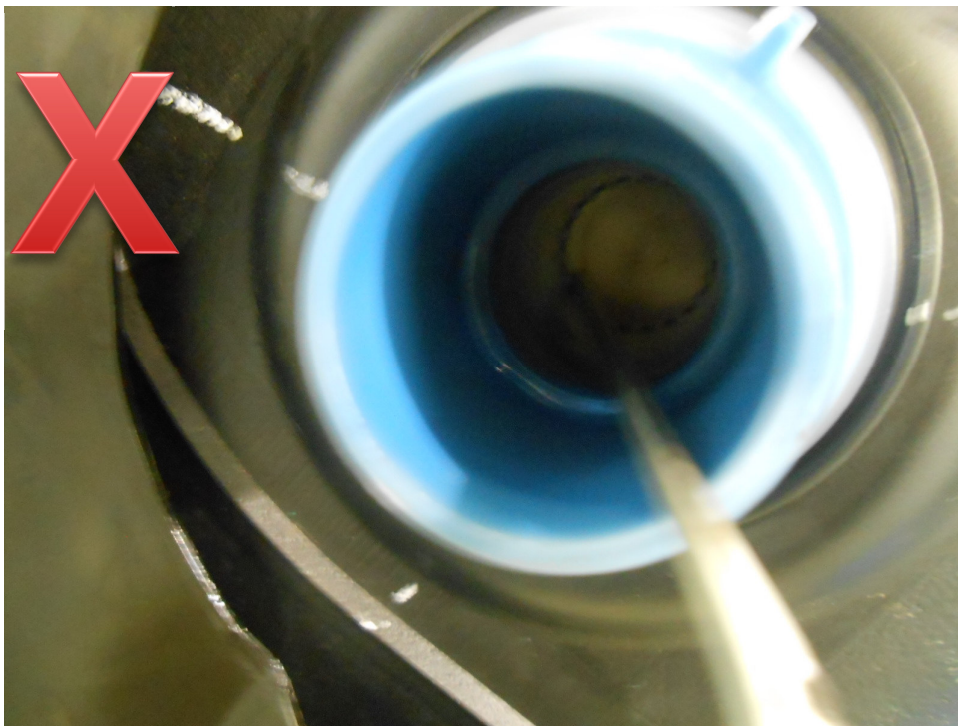
If the anti syphon device is dislodged it will cause the fuel flow to be disrupted and can cause shut off problems (as per the example below):

- ONLY REPLACE THE FUEL FILLER IF A CLEAR FAULT IS OBSERVED. REPORT THE FAULT FOUND ON AN EPQR.
- If cause 1 is identified, correctly install the anti-siphon device.
- If cause 2 is identified, replace the fuel filler pipe (ensure the filler head is in the correct orientation on the new part).
- If cause 3 is identified, reroute the fuel pipe in the tank to prevent the check valve from being obstructed. Also take care to ensure the fuel sender is not obstructed.
- Fill with fuel and check to see if the issue is repaired. If so, report the fault found and fixed on EPQR. If not, raise a TA for further assistance to identify the fault.

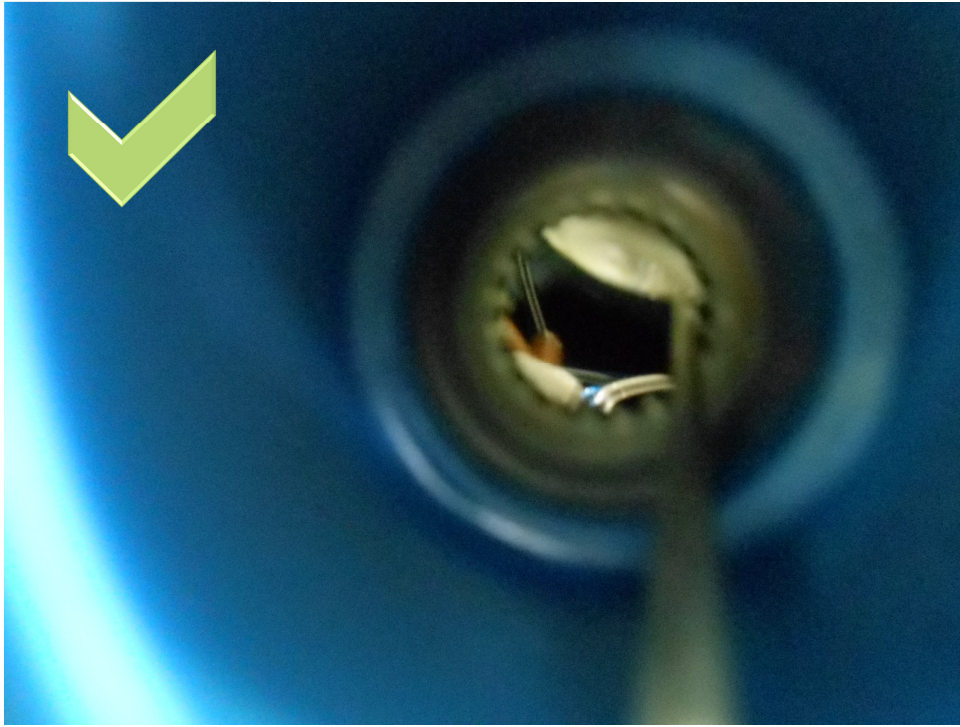
1. Flap should appear as per figure 1 and 2.
2. It must hinge from the top as per figure 2.
3. If it hinges from the bottom (as per figure 3.), the filler pipe must be replaced.
