L405 & L494 Range Rover & Range Rover Sport Fuel Filling Concerns

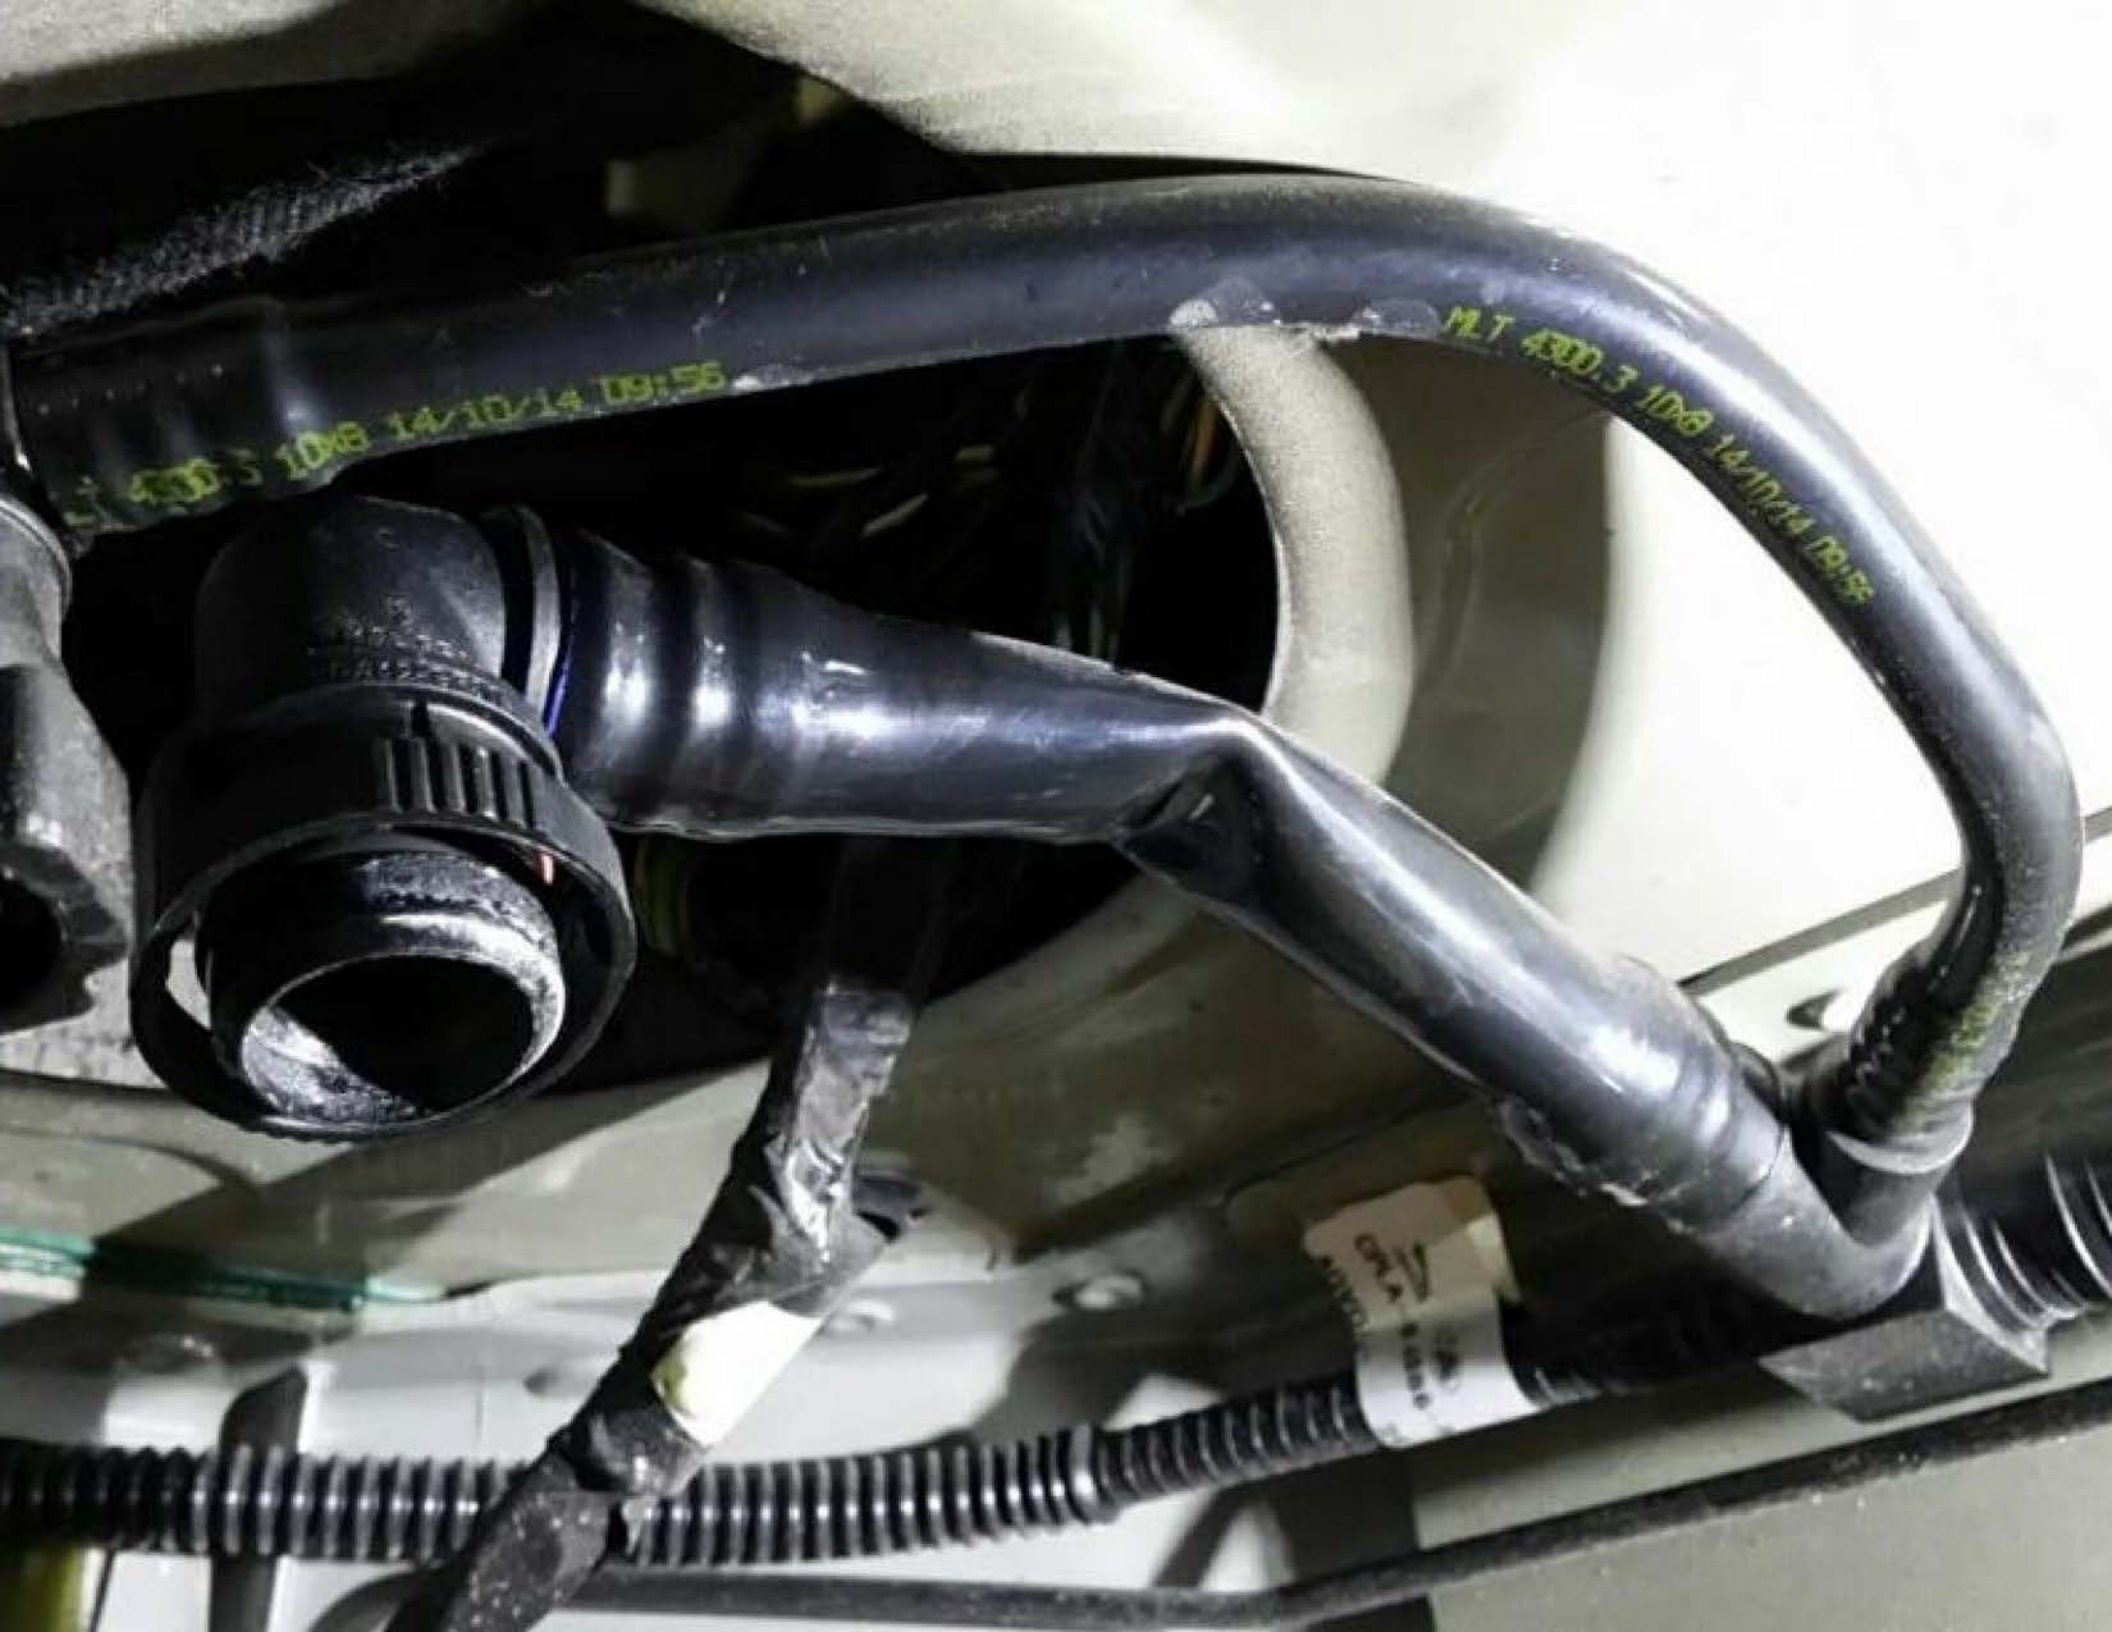
Reports have been submitted showing debris in the filler pipe was causing an obstruction and fuel filling problems.

Debris can be identified using a borescope (no need to remove the fuel filler pipe).

- ONLY REPLACE THE FUEL FILLER IF A CLEAR FAULT IS OBSERVED. REPORT THE FAULT FOUND ON AN EPQR.
- If cause 1 is identified, correctly install the anti-siphon device.
- If cause 2 is identified, replace the fuel filler pipe (ensure the filler head is in the correct orientation on the new part).
- If cause 3 is identified, reroute the fuel pipe in the tank to prevent the check valve from being obstructed. Also take care to ensure the fuel sender is not obstructed.
- Fill with fuel and check to see if the issue is repaired. If so, report the fault found and fixed on EPQR. If not, raise a TA for further assistance to identify the fault.
