QUARANTINE NOTICE

Reference number:	QN-08-0042	Issued: 24 November 2016
Subject:	Fluid Leakage from the Clutch Slave Cylinder	
Model(s):	V8, V12 Vantage, GT8 and GT12, ASM Transmission only	
VIN range:	Refer to separately published VIN list	
Applicable to:	All Dealers	
Distribute to:	After Sales Manager Executive Manager Service Manager Sales Manager	Warranty Staff Technician(s) Parts Staff

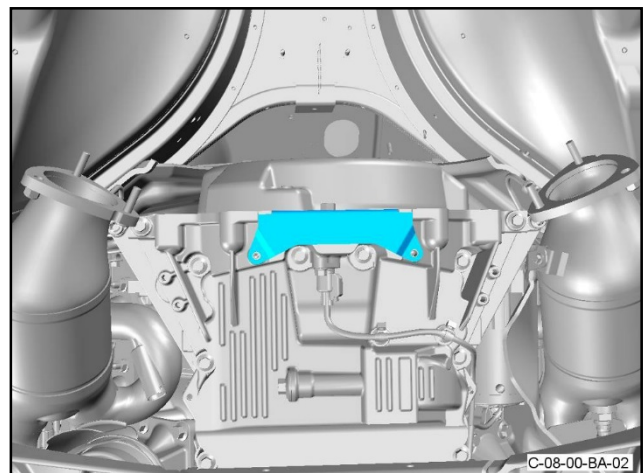
Figure 2

4. Examine the interior of the clutch housing for fluid leaks.

3. Remove the cover plate (refer to Figure 2).
