# QUALITY ACTION

## CAMPAIGN BULLETIN SD Card

Reference: PC481  
Date: October 5, 2016

# PC481 - 2016 MURANO (Z52) NAVI H/U SD CARD

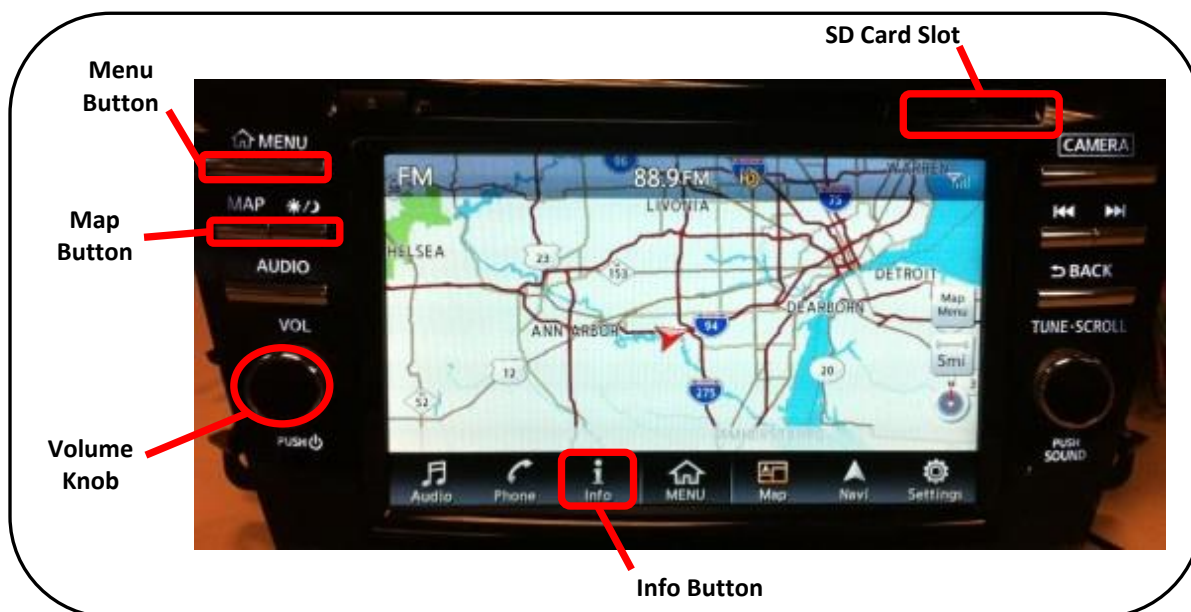
Figure 2

1. Verify the transmission range is in the "PARK" range and the parking brake is applied.
2. Start the engine and let it idle.
3. Wait for navigation MAP screen to be displayed on the screen. (Figure 2).

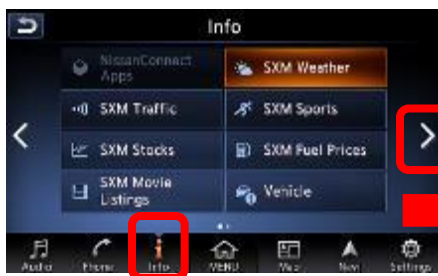
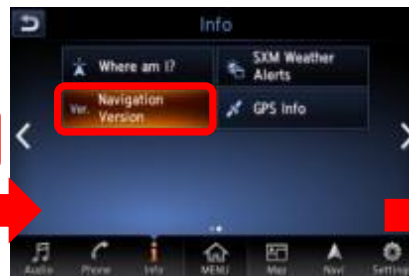
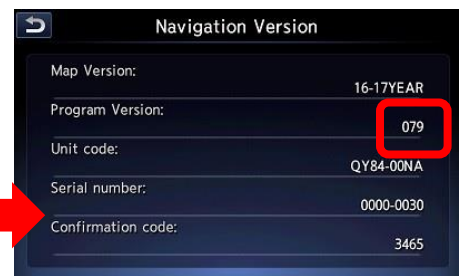
4. Obtain the original Navigation software version in the AV Control Unit and write it down (Figures 3, 4 and 5).

- Press the **"Info"** button on the lower status bar
- Press **">"** button to scroll to the next screen
- Select **"Navigation Version"**
- Write down **"Program Version"** found on right side of the display screen.

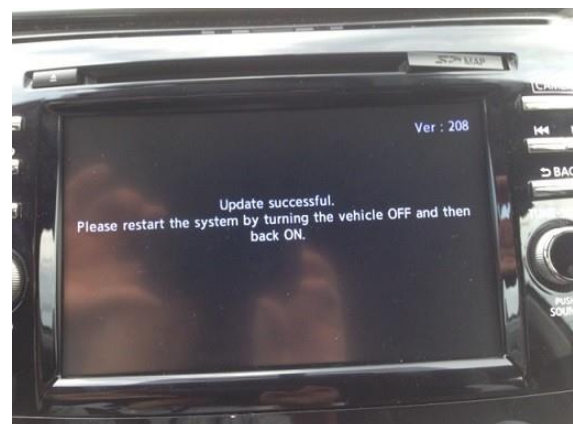
Figure 7

- Wait for **“Update successful. Please restart the system by turning the vehicle OFF then back ON”** confirming the software update is finished (Figure 7).

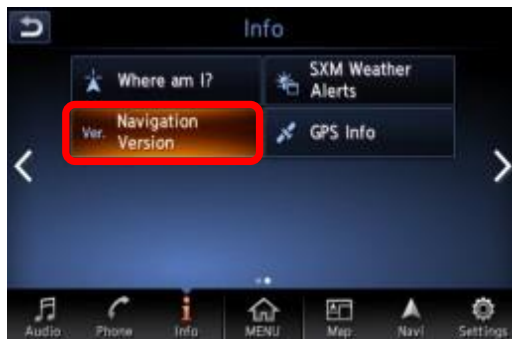
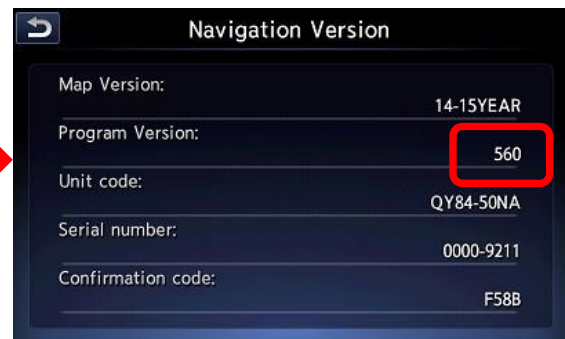
- Start the engine and let it idle.
- Press the **"Info"** button on the lower status bar, press the **">"** button to scroll to the next screen, select **"Navigation Version"**, and confirm the **"Program Version"** is **560**.
