GROUP TRA	MODEL ≥ 2011MY
	NUMBER 055	DATE October 2014
TECHNICAL SERVICE BULLETIN		
SUBJECT: INHIBITOR SWITCH DIAGNOSIS INFORMATION

SUBJECT: INHIBITOR SWITCH DIAGNOSIS INFORMATION

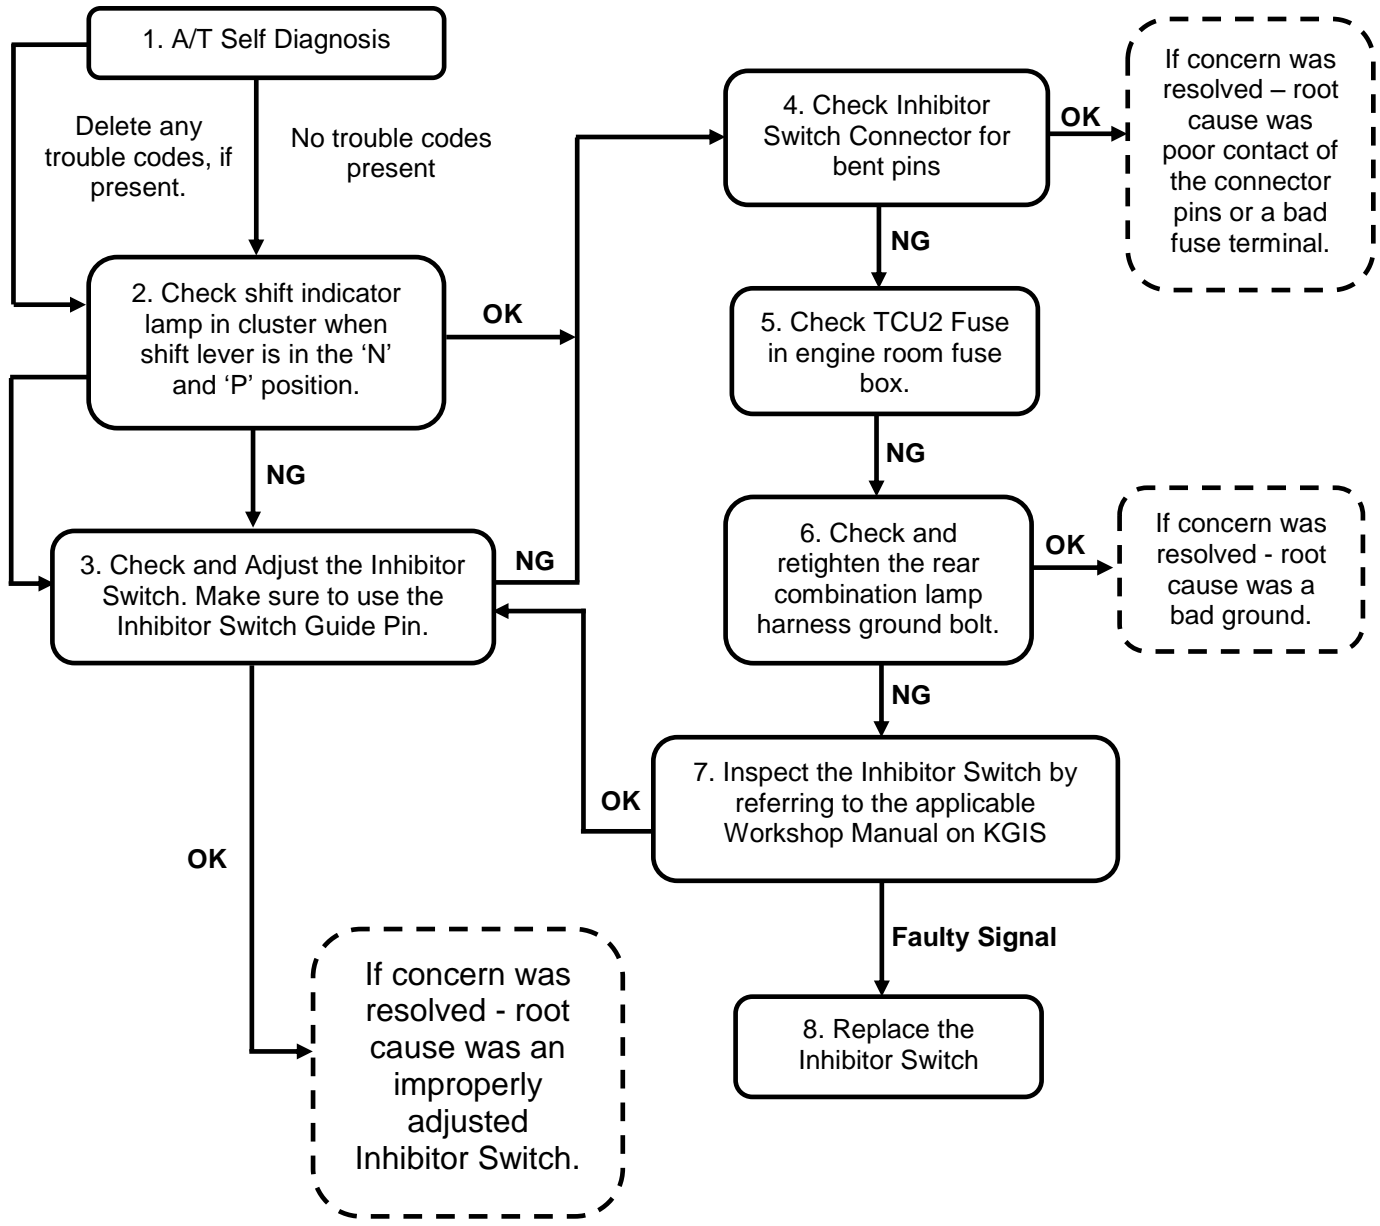
Diagnostic Flowchart:

All of the concerns listed above may be due to the Inhibitor Switch or related circuits not allowing the correct gear position signal to be sent to the TCM. This condition occurs more often following a heat soak, after long periods of driving in regions with high ambient temperatures or during the summer months. Attempt to duplicate the customer's concern as described in the repair order under the correct heat soak conditions.
