VOLVO CAR SERVICE AND PARTS BUSINESS

# **Technical Journal**

### TITLE: Oil leakage from plug in Variable Valve Timing pulley

REF NO:	ISSUING DEPARTMENT:		ARKET:
TJ 29131.3.0	Technical Service		s and Canada
3 US 7	PARTNER:	ISSUE DATE:	STATUS DATE:
	7510 Volvo Car USA	2016-08-08	2016-08-09
FUNC GROUP: 2150	FUNC DESC: Transmission	Page	1 of 9

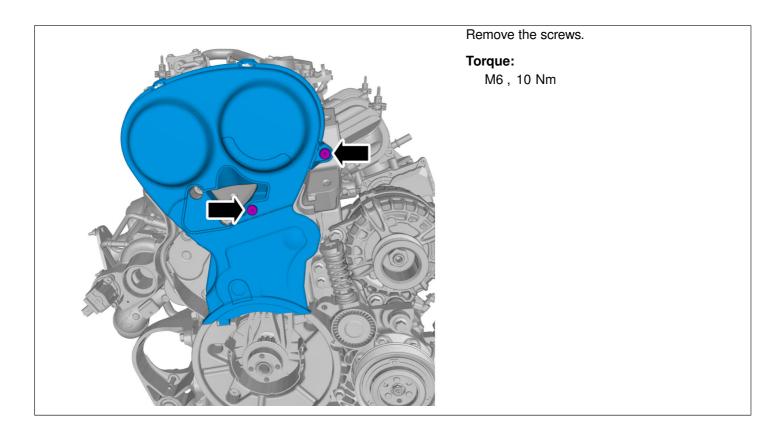
Customer may experience a low oil level warning in DIM and /or oil leakage from the engine. The oil may leak due to a crack in the plug from the VVT pulley (see attached photo).

Replace both plugs in both VVT-pulleys according to the attached instruction. Plug PN:31375877 If the timing belt is effected with oil, replace the timing belt according to VIDA instructions.
