TITLE:							
Rear door, water intrusion							
REF NO:	ISSUING DEPARTMENT:	CAR MARKET:					
TJ 31542	Technical Service	United States and Canada					
	PARTNER:	ISSUE DATE:	STATUS DATE:				
3 US 7	7510 Volvo Car USA	2016-05-13	2016-05-17				
FUNC GROUP:	FUNC DESC:						
8400	Outside trim parts, glass, sealing mould	Page 1 of 7

VOLVO	olvo Car Customer Service	TJ 31	1542
Title	Weatherstrip, door window, rear	Page	1 (5)
Action	Adjustment	Operation number:	98630-2

Model year	Model	
2016	XC90	(16-)

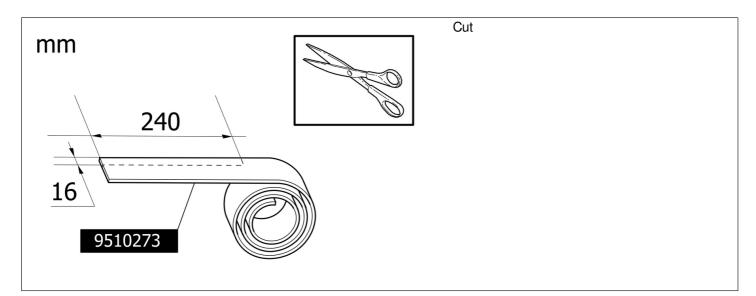
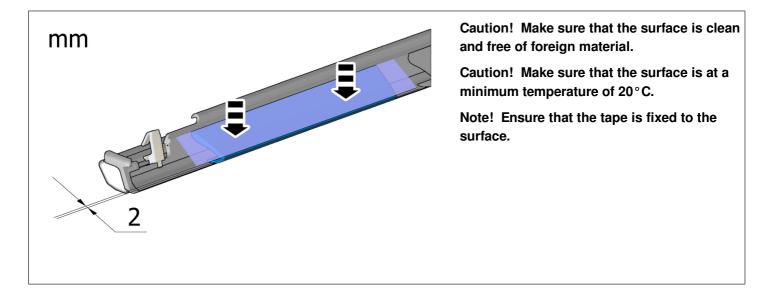
TJ 31542	Page 3 (5)
Removal	
	Caution! Make sure that the component is not bent. Remove the marked part. On both sides.
Installation	
	Make sure to replace the marked component with a new.
31402039 X2
