I-Shift Transmission With Mixed Components
 Version-C
 AT2512C, ATO2512C, and ATO3112C
 VN, VHD, VT

FSB 431-001, I-Shift Transmission With Mixed Components

(November 2010)

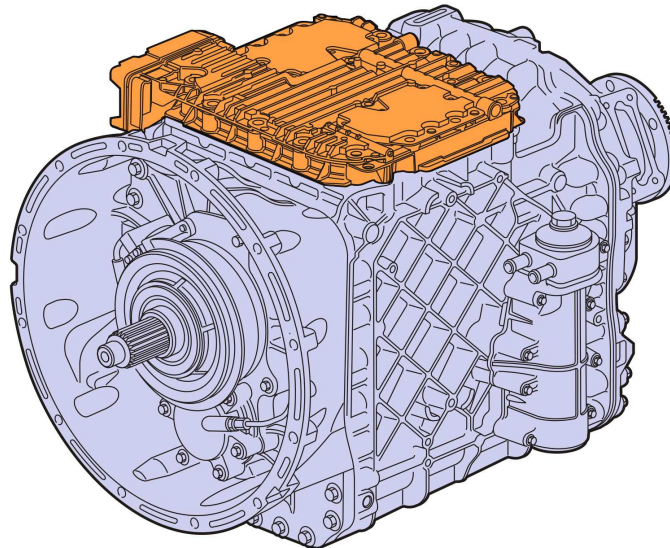
W4059589

As of June, 2009 the new generation I-Shift transmission (Generation D) was released for production. There are three parts used in combination with the generation D (New) or C (Old) versions of the I-Shift transmissions (see figure below).

- 1 Transmission Electronic Control Unit (TECU).
TECU-D (New generation) or TECU-C (Old generation)
- 2 Cable harness including speed sensor.
Speed-sensor-D (New generation) or Speed-sensor-C (Old generation)
- 3 Sensor wheel.
72 tooth (New Generation) or 30 tooth (Old Generation)
