SERVICE BULLETIN

APPLICABILITY: 2014-2016MY Forester

NUMBER: 12-204-16R

SUBJECT: Pop, Click, Creak Sounds from the Rear Body Area

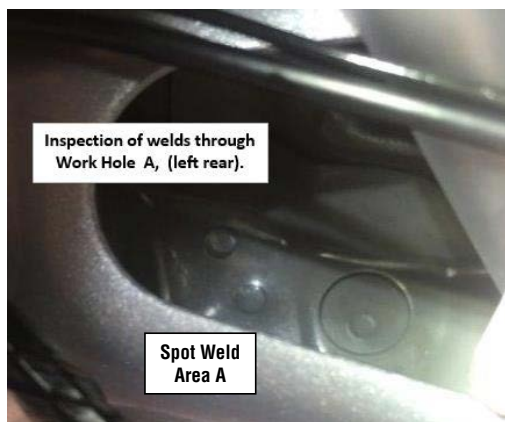
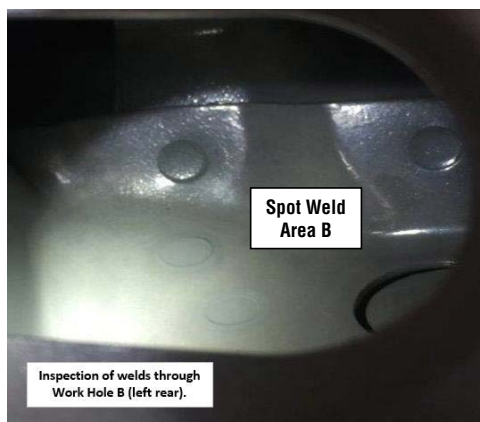
Use the reference photos provided below to help with identification of the areas described throughout the service procedure steps. **NOTE:** In order to better show the described weld and seam areas, the orientations of these photos may differ in comparison to how they actually appear on the vehicle.
