SERVICE BULLETIN

APPLICABILITY: 2015-2017MY Legacy and Outback
 2012-2016MY Impreza
 2013-2016MY XV Crosstrek
 2015-2016 WRX / WRX STI
 All Models Listed with Seat Lifter Feature

NUMBER: 12-206-16
DATE: 07/28/16

SUBJECT: Seat Cushion Frame Surface Rust Treatment Procedure

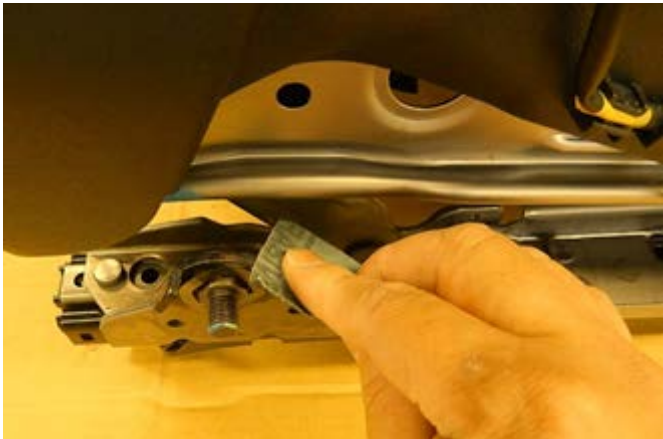
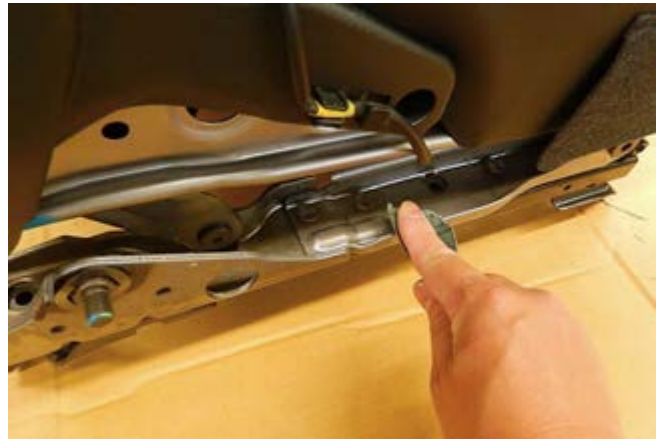
This bulletin provides a procedure to address a customer reported cosmetic condition of surface rust appearing on the inner seat cushion frame of the front seat assemblies.

- Remove the rust from the areas indicated in the illustration above using Scotch Brite, emery cloth and/or sandpaper as necessary.
