SERVICE BULLETIN

APPLICABILITY: 2015-2016MY Legacy and Outback
 2015-2016MY Impreza and XV Crosstrek
 2016MY Forester
 2016MY WRX

NUMBER: 15-198-16R
DATE: 05/02/16
REVISED: 07/08/16

SUBJECT: Reprogramming File Availability to Address Operational Concerns with “Gen 2” Fujitsu-TEN (F10) Navigation and 7” Display Audio Units

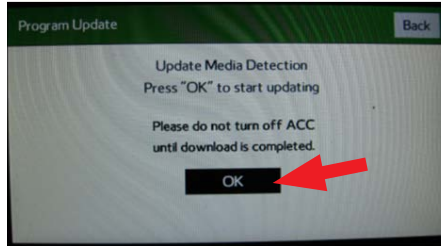
NOTE: The "OK" button will not activate (turn black) if the wrong Update File(s) are on the flash drive. Re-format the flash drive and reload the proper Update Files starting from the beginning of Step 2.

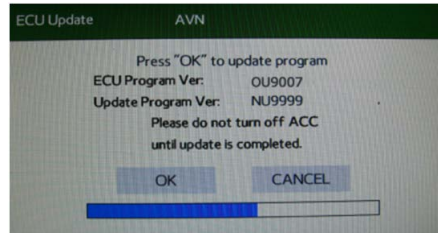
Once the updating starts, the status bar may need to complete more than once and could take up to about 15 minutes.

If the progress bar stops, please wait 15 minutes. If the progress bar does not change even if after 15 minutes, turn ACC OFF and back ON again then, restart the update procedure from **Step 4**.

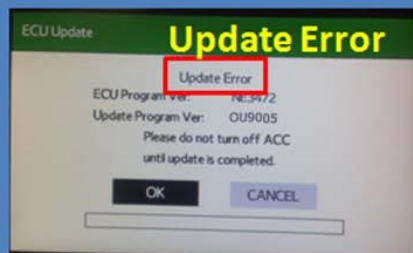
If "Update Error" screen is displayed as shown below:

Select "OK".

ACC OFF then back ON again

Perform the Version Update again from Step 3.
