Service Bulletin

PRELIMINARY INFORMATION

Subject: Intermittent Home Screen Icon/Navigation Overlay, Intermittent RVC Black Screen with Guidelines, Phone Pairing Not Included on the Phone Page, Routing Issues on Toll Roads in Mexico

Models: 2015 Buick Enclave
2015 Chevrolet Traverse
2015 Chevrolet Captiva
2015 GMC Acadia
Equipped with Radio RPO UI2, UI4, UI5, UI6, UI7 or UI8

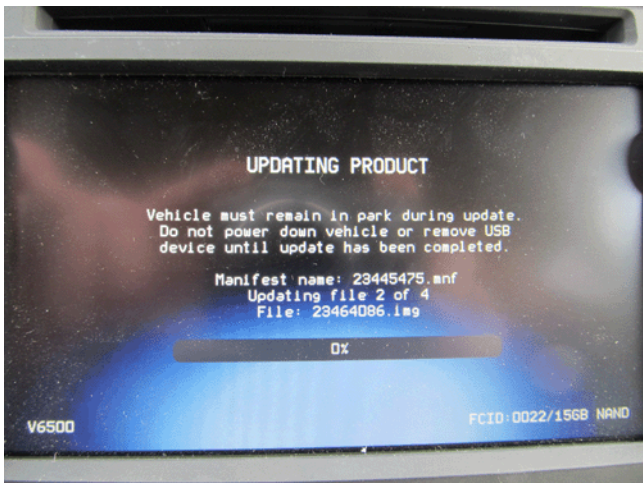
4. When the update info screen comes on, select "ACTUALIZAR."

Note: If ACTUALIZAR (UPDATE) is not selected within 10 seconds, the screen will disappear and the USB drive will have to be removed and inserted again to start the update process.
