# Service Bulletin

**Subject:** Delayed Engagement After Sitting With Engine Off - Torque Converter Fluid Drain Back

<b>Involved Region or Country</b>	North America and N.A. Export Regions
-----------------------------------	---------------------------------------

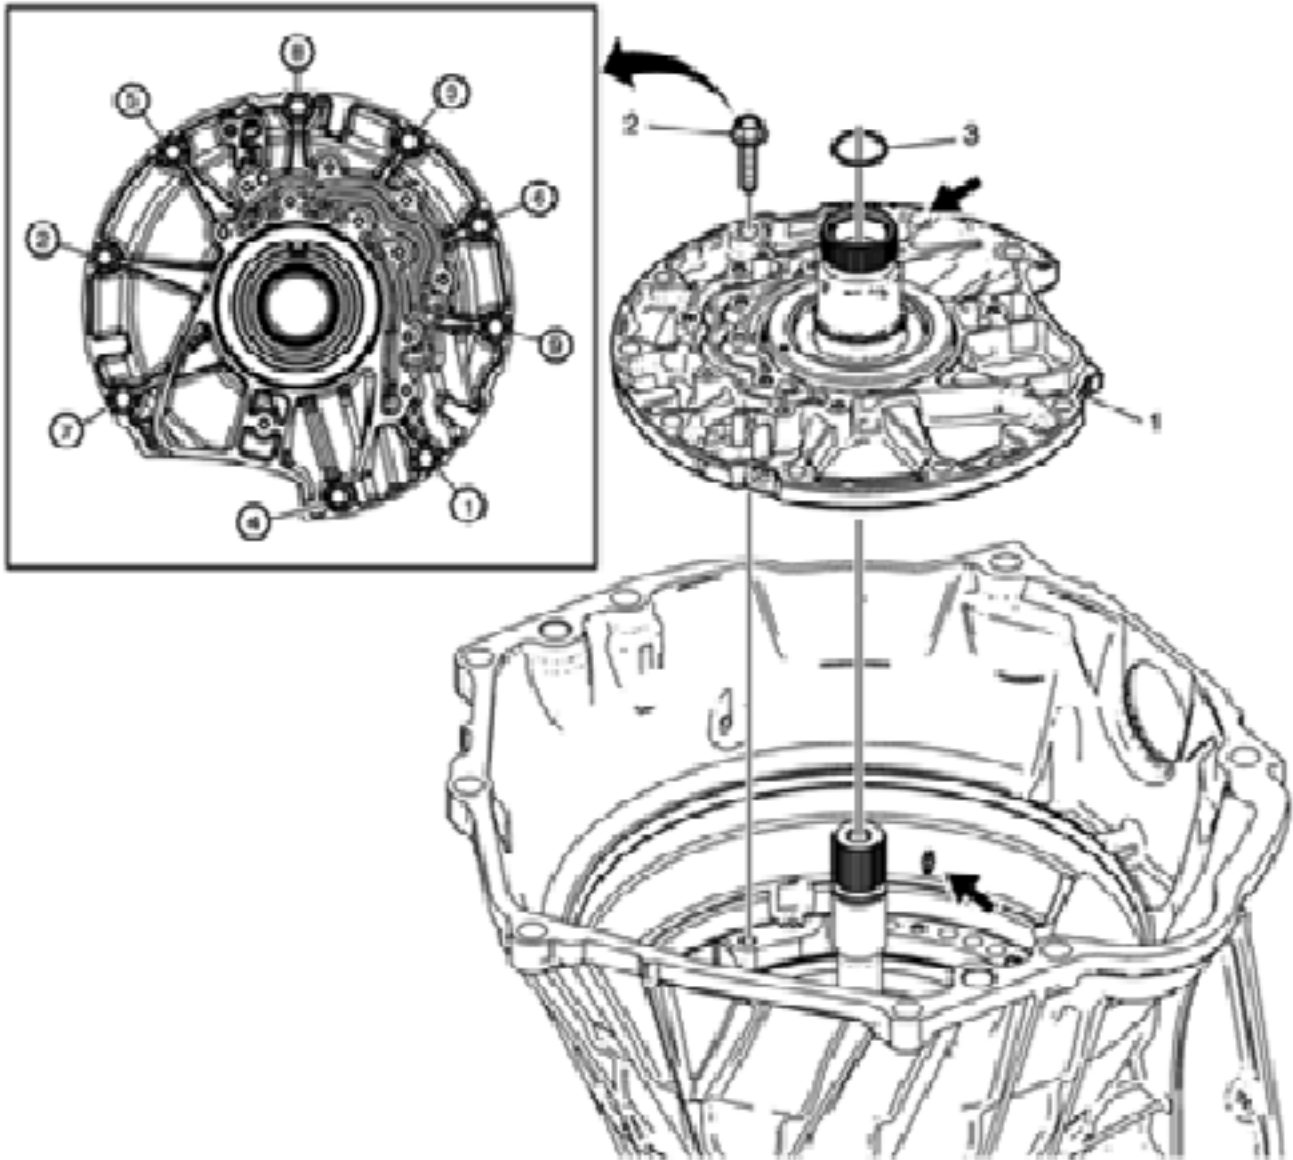
**Caution:** Size the converter fluid seal ring for at least 5 minutes after installation to obtain proper seal ring size. Failure to do so may cause internal transmission leaks and transmission damage.

- Using the *DT-50912* Seal Installer (8L90) or *DT-51196* Seal Installer (8L45), install a NEW torque converter fluid seal (1) on the stator shaft support assembly. Size the seal using the *DT-50912-1* Seal Sizer.
- Install 2 NEW 1-3-5-6-7 Clutch Fluid Seal Rings (2).
