Service Bulletin

PRELIMINARY INFORMATION

Subject: Floor/Carpet Wet at Front Passenger Side Under Dash, or at Any Front/Rear Footwell Area

Models: 2011-2016 Chevrolet Caprice PPV
2014-2016 Chevrolet SS

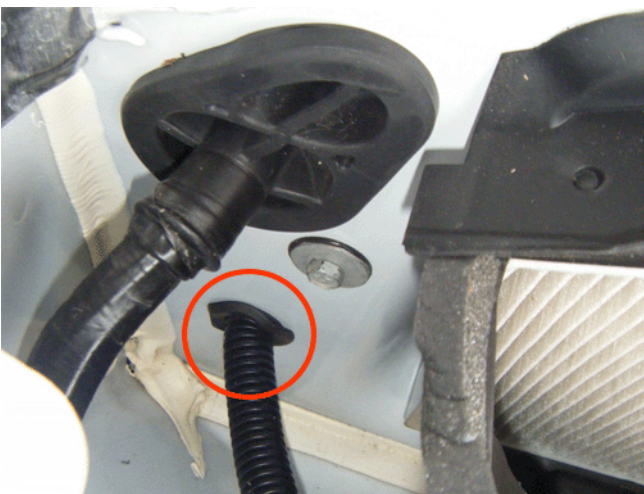
4. Inspect the cowl area outside the HVAC case for the possible existence of a wiring harness associated with certain police equipped vehicles. If equipped, the grommet/hole location for the harness will be just below the bolt (1) shown in the graphic above.

5. If equipped with the additional harness, complete the following repair steps:

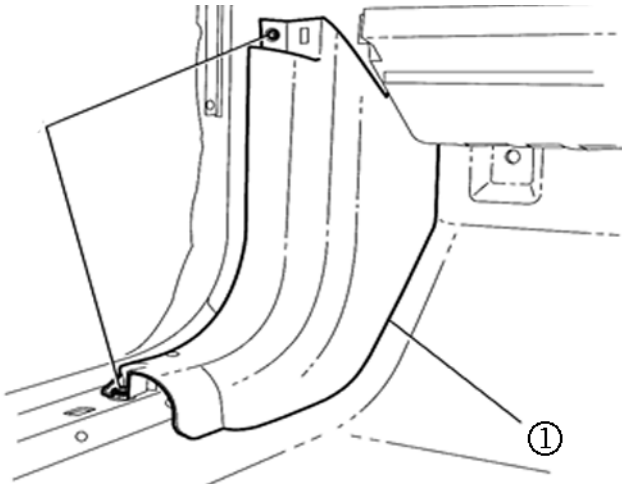
The cause of this condition may be an improperly sealed body seam at the left front cowl/plenum area, behind the wiper motor. Water can enter this seam, flow down the A-pillar and front door sill and may puddle in the rear footwell.

1. Remove the driver side kick panel. Refer to *Body Hinge Pillar Trim Panel Replacement* in SI.
2. Remove the lower inlet grille panel. Refer to *Inlet Grille Panel Replacement (Lower Panel)* in SI.
3. Remove the windshield wiper module. Refer to *Windshield Wiper System Module Replacement* in SI.
4. Inspect and water test the underside plenum seam.
