**Countries:** CANADA, UNITED STATES **Document ID:** IK2600230  
**Availability:** ISIS, Bus ISIS, FleetISIS, IsSIR **Revision:** 7  
**Major System:** PROGRAMMING SUPPORT **Created:** 9/29/2016  
**Current Language:** English **Last Modified:** 11/29/2016  
**Other Languages:** NONE **Author:** Kendall Prohett  
**Viewed:** 2138

**Title:** OnCommand™ Link Essential Update**Applies To:** OnCommand Link

This document will inform the user of an essential update made to the OnCommand Link device, used for Over The Air Programming. This essential update addresses issues regarding false DTCs and/or flashing lights on the Instrument Cluster.

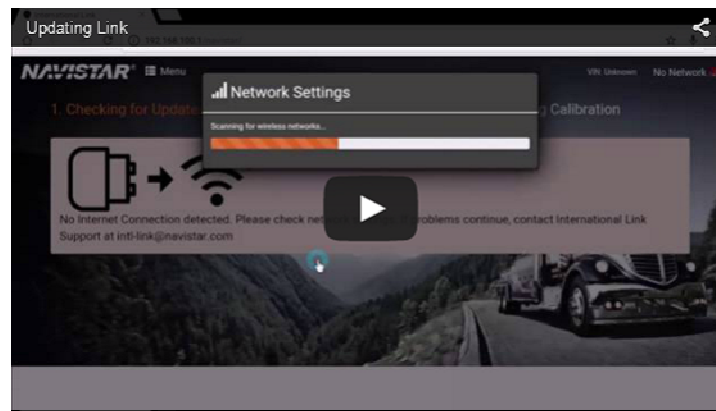
The YouTube video below also shows step-by-step process to update the device.

6. Wait **at least** 30 minutes before attempting to reconnect; it may take up to 1 hour.
7. Reconnect to Link SSID from your personal device.
8. Open your web browser and go to <http://192.168.100.1/navistar> and check the version listed under the MENU button is listed **AT LEAST** 1.2.33 (Figure 1) or higher.
