MODEL
2017MY
Sorento (UMa)

NUMBER
159 (Rev 1, 12/20/16)

TECHNICAL SERVICE BULLETIN

SERVICE ACTION: DRIVER'S WINDOW
RUN CHANNEL REPAIR (SA259)

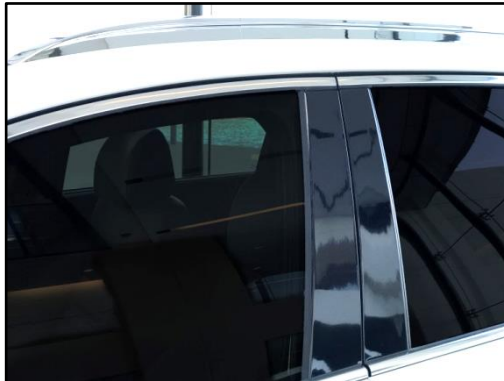
This bulletin provides the procedure for inspecting and if necessary, repairing the driver's window run channel on some Sorento (UMa) vehicles, produced from April 4, 2016 to October 14, 2016, which may experience a wind noise at the driver's window. This concern is caused by a gap between the driver's window glass and window run channel. Follow the procedure outlined below to inspect and if necessary, install a foam pad on the window run weatherstrip. Kia is requesting the completion of this Service Action on all affected vehicles in dealer stock, prior to delivery. Before conducting the procedure, verify that the vehicle is included in the list of affected VINs.
