| | GROUP BOD | MODEL 2017MY Sedona (YP) |
| | NUMBER 163 | DATE December 2016 |
| SUBJECT: SERVICE ACTION: FRONT DOOR GLASS RUN CHANNEL INSPECTION (SA263) | | |

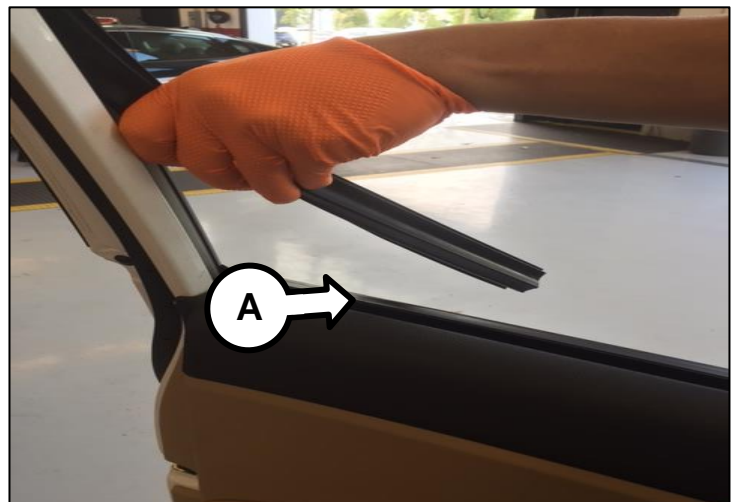
**CAUTION**

Do not use any pliers, or other tools that may damage run channel

2. Remove the lower section of run channel from the door frame by pinching the outer lip towards the middle, and pulling straight out.

Once it is out of the frame channel, pull upwards to remove the lower end (A) of the channel from the door frame
