Service Bulletin

Subject: Air Conditioning Not Getting Cold Enough or Blows Warm Air

Brand:	Model:	Model Year:		Breakpoint		Engine:	Transmission:
		from	to	from	to		
Chevrolet	Sonic	2015	2016	SOP 2015	April 1, 2016	All	All
Chevrolet	Trax (Region of Build, 3: 1st Position of VIN)	2015	2016	SOP 2015	April 1, 2016	All	All

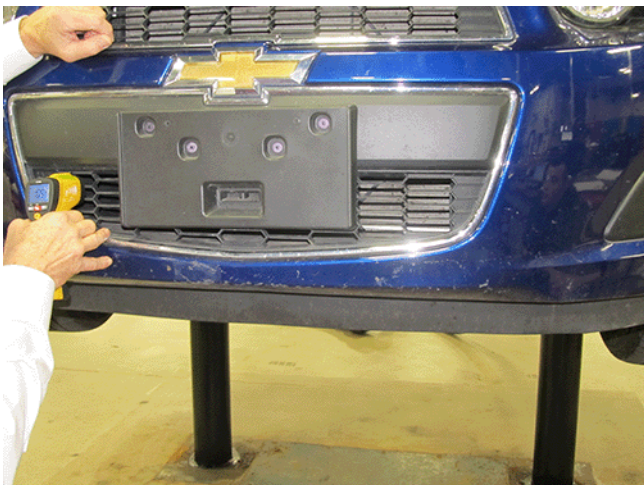
1. Perform a diagnostic check of the A/C system. Refer to *Air Conditioning (A/C) System Performance Test* in SI. If no leaks and a proper refrigerant charge were found, continue to step #2 starting the A/C condenser temperature variation test.
2. Partially raise and support the vehicle. Refer to *Lifting and Jacking the Vehicle* in SI.
3. Turn the A/C system on high blower / non - recirculation mode, and run for a minimum of 1 minute, prior to taking any temperature measurements.
