**Document ID:** IK0800522

**Title:** Repair Information for Damaged Headlight Connector

**Applies To:** Certain DuraStar, CE / BE Bus, WorkStar, 1300, TranStar

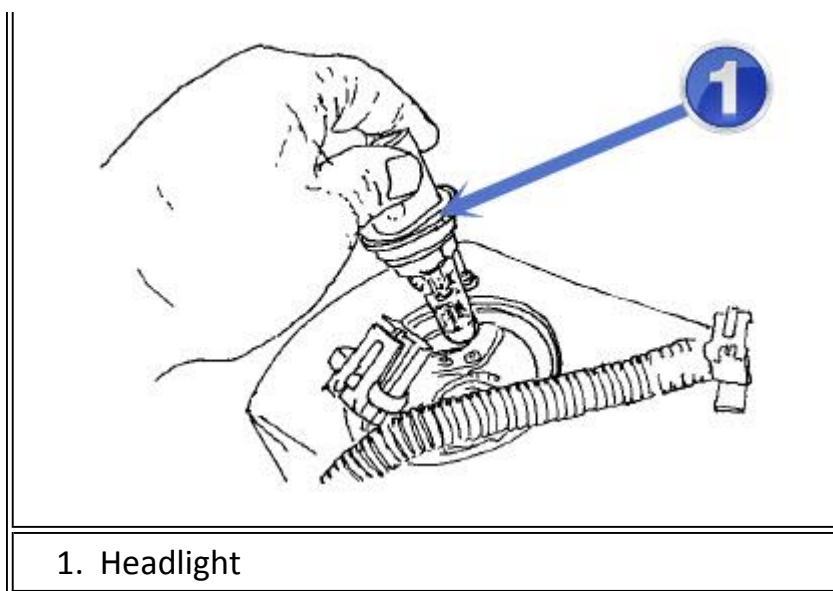
3. Remove the headlight.

1. Replace the socket pigtail plug, with the high temperature pigtail.
  - Use the closed barrel butt connectors to crimp and solder the wiring.
  - Follow proper wire repair procedures as outlined in [IK0800269 - Proper Wire Repair](#).
2. To replace the headlight, if required, remove the headlight retaining bezel. See Figure 7 below.
