**Title: 2010 MaxxForce 11 & 13 and 2013 N13 HT EGR Core Removal/Installation**

**Applies To: 2010 MaxxForce11/13, 2013 N13, All Truck Models**

A faster, more effective procedure for High Temp (HT) Exhaust Gas Recirculation (EGR) Cooler repair has been developed. This document will guide the user through the procedure of in chassis replacement of the cooler core for a 2010 Emissions MaxxForce 11 or 13 or 2013 Emissions N13. The new procedure must be followed in lieu of HT cooler assembly replacement for **INTERNAL** leaks.

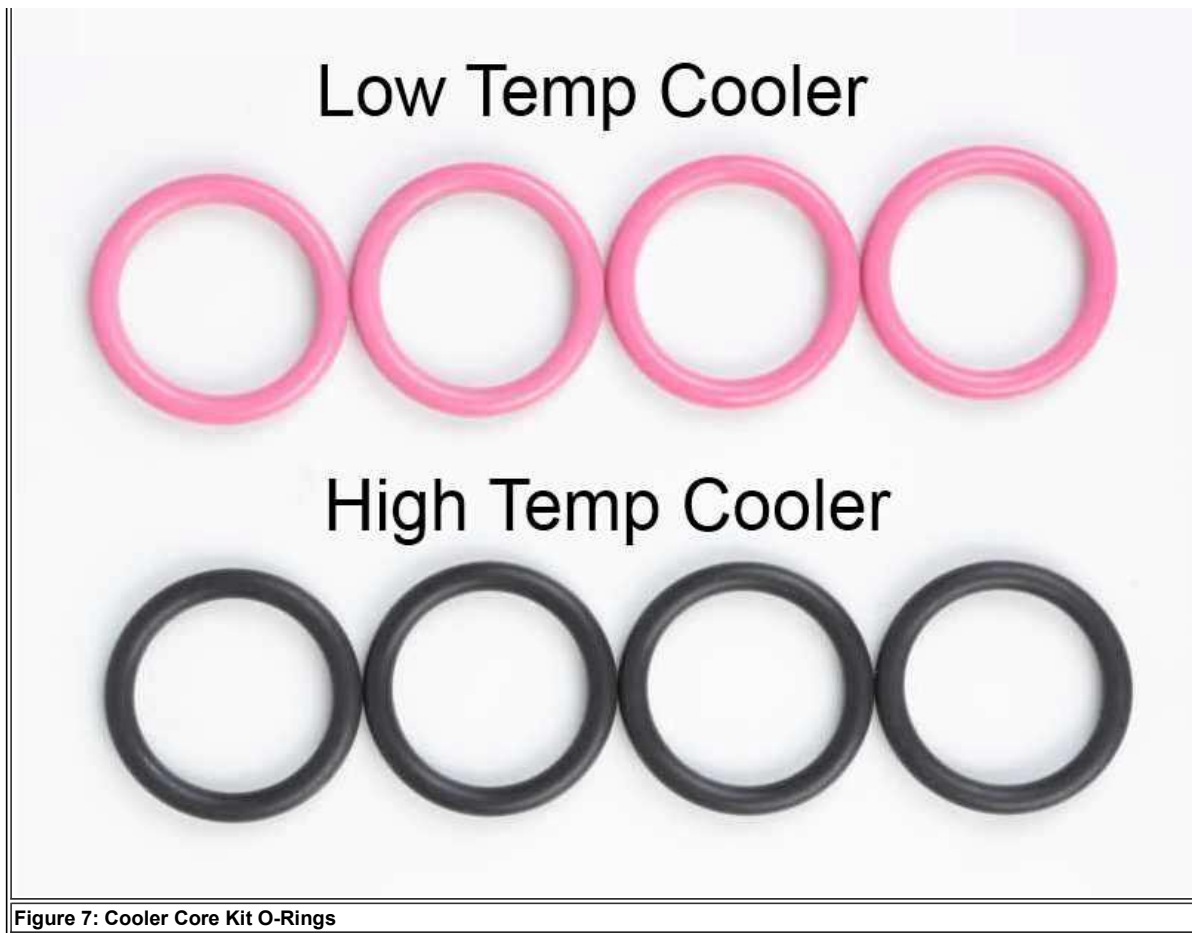
**Make sure there is no debris in the o-ring grooves prior to installing the o-rings** (they don't need to be spotless, just no soot chunks that will push the o-ring out of round). In development, this was the only instance of damaged o-rings (core outlet manifold cut off a section of the o-ring), outside of not actually seating them.
