TECHNICAL SERVICE BULLETIN

Group:	48-SUSPENSION
Bulletin No:	SB-16-006
Issue Date:	4-20-2016
Vendor Ref.:	HMM-160308-B1

REAR SPRING PAD LOOSE

SUBJECT VEHICLES: 11MY-16MY Conventional Trucks (238, 258, 268, or 338)

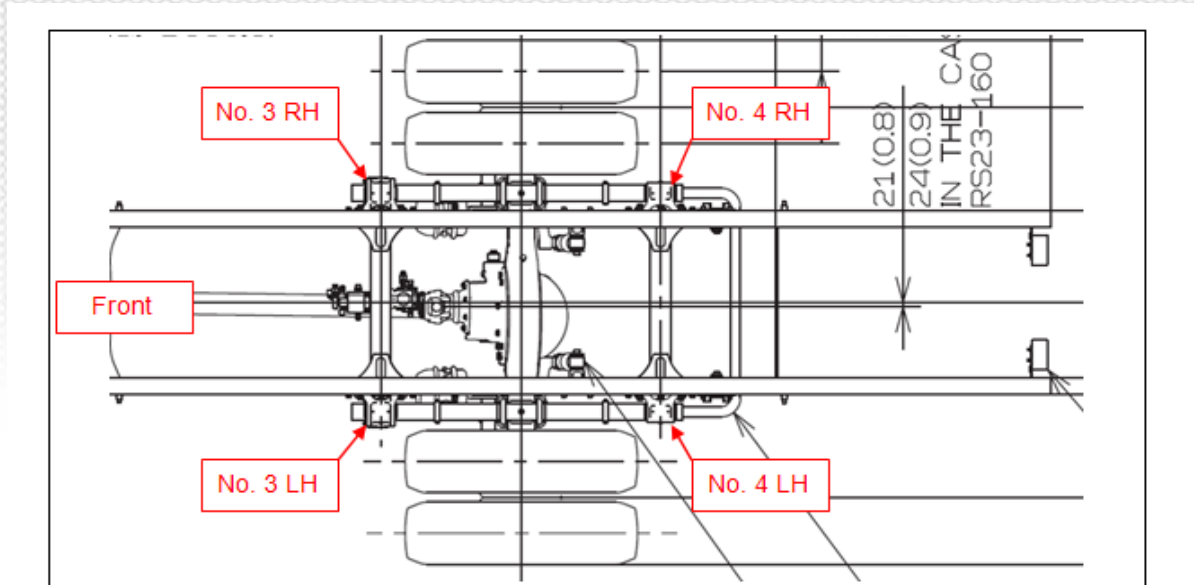
Some vehicles built before January 2016 and equipped with a leaf spring rear suspension may experience a dislodged or missing spring pad. As an enhancement, the rear axle leaf spring hanger design has been changed to eliminate the spring pad. In the event that one or more spring pads have become dislodged or found missing, all four rear axle leaf spring hangers should be replaced with the enhanced design hangers.
