## Technical Service Bulletin

**Solitude 360RL Slide Room Flex-Guard Strap -  
DS Dinette Slide**

16-005

Solitude 360RL

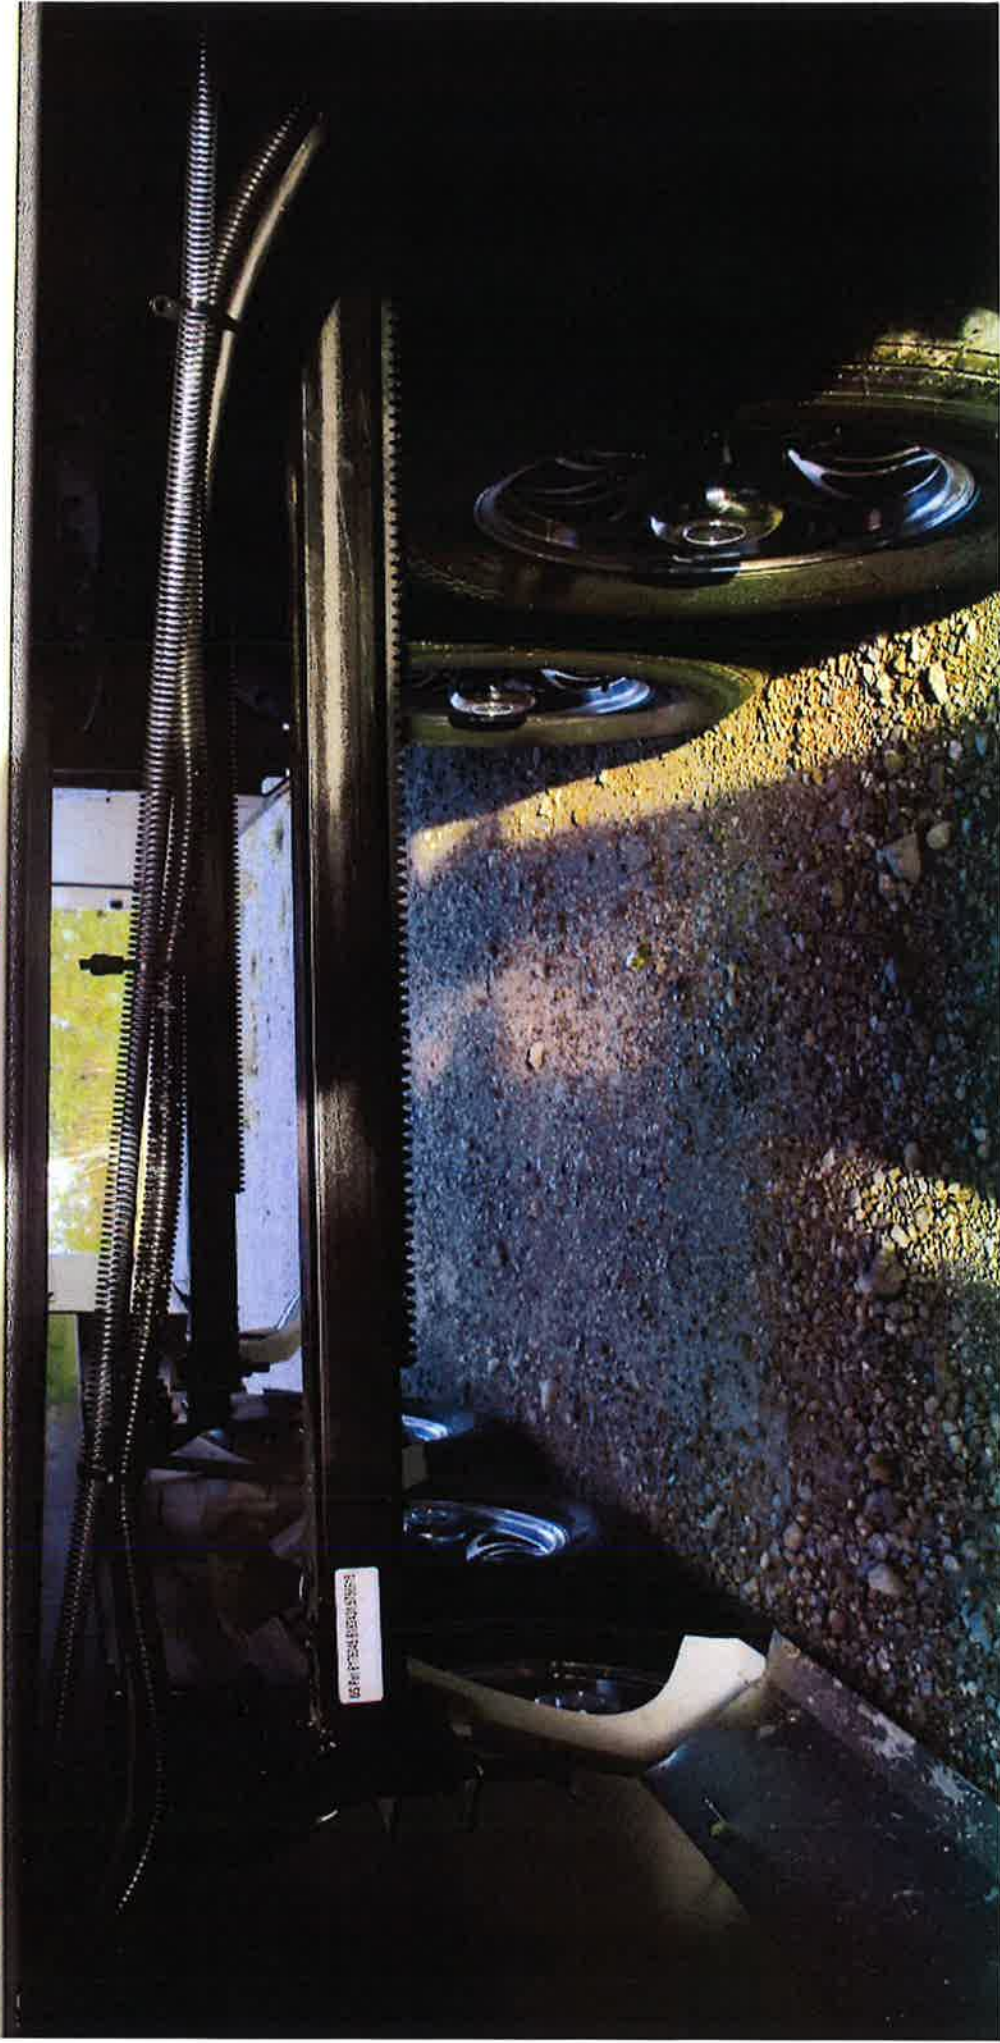
**Completed repair will keep  
wires and spring from  
possibly rubbing tire...**
