GROUP	NUMBER
AUTOMATIC TRANSMISSION	16-AT-006-1
DATE	MODEL
NOVEMBER 2016	Accent (RB), Azera (TG/HG), Elantra (UD/MD/GD/JK/AD), Santa Fe (CM/AN/NC), Sonata (YF/YF HEV/LF/LF HEV/PHEV), Tucson (LM/TL), Veloster Turbo (FS)

AUTOMATIC TRANSAXLE SHIFT LEVER DIAGNOSIS (6-SPEED)

This TSB supersedes 16-AT-006 to update the Service Procedure (Step 14).

Description: The shift lever on some 6-speed vehicles may intermittently not shift out of Park. This bulletin provides the diagnostic procedures to correct this condition.

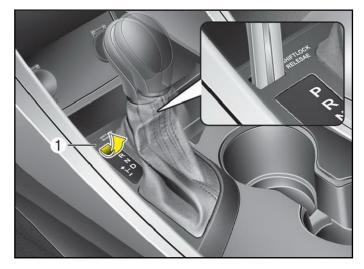
- 1. If the condition is "Accessory power remains on when shifting into Park", go to Step 10 and replace the shift lever assembly. If not, go to Step 2.
- 2. Turn the ignition key to the **ON** position or depress the Start/Stop Button two times and depress the brake pedal.
 - Confirm the shift lever moves smoothly into all gear positions.
 - If the shift lever will not move out of Park, go to Step 3.
 - If the shift lever operates properly, go to Step 4.
- 3. Use the ignition key or a screwdriver to engage the shift-lock override. Move the shift lever through all gear positions to confirm that it operates properly.
 - If the shift lever moves out of Park, go to Step 4.
 - If the shift lever does not move out of Park, replace the shift lever.
