SERVICE BULLETIN

Classification: EC16-011a	Reference: NTB16-030a	Date: December 1, 2016
------------------------------	--------------------------	---------------------------

2013-2016 ALTIMA WITH QR25DE ENGINE; MIL ON WITH DTC P0101

APPLIED VEHICLE: 2013-2016 Altima (L33)

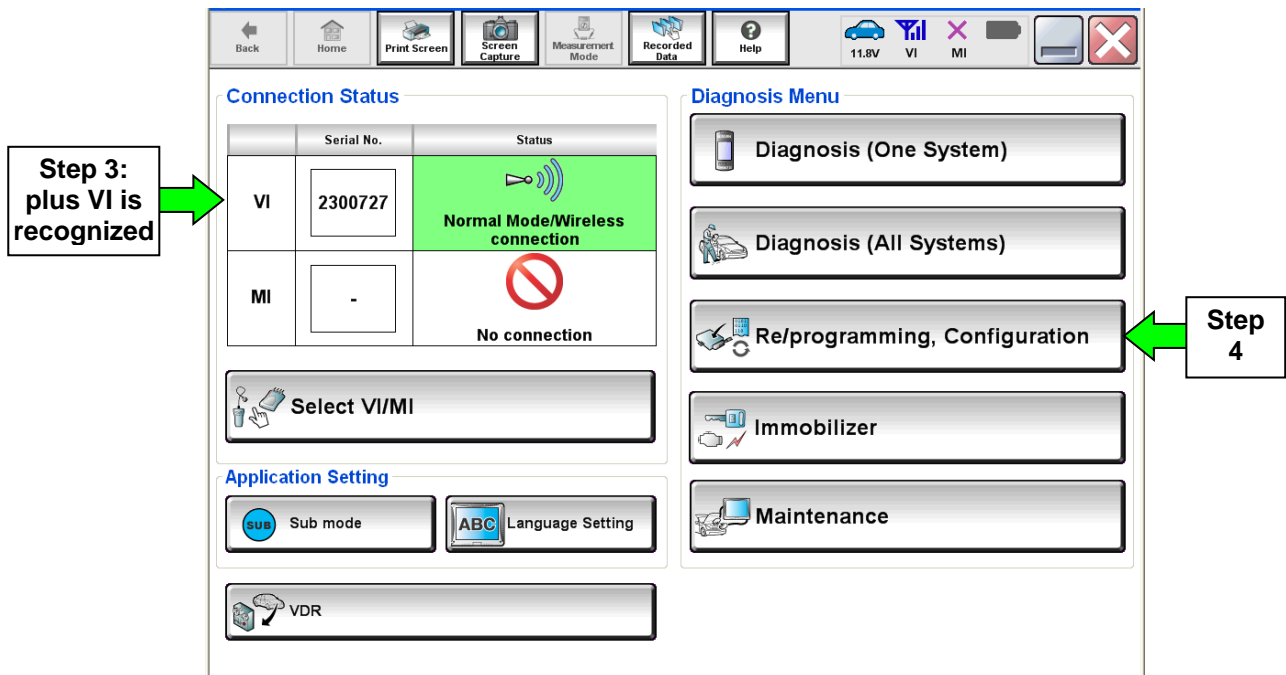
Figure 1

1. **Connect the CONSULT PC** to the vehicle to begin the reprogramming procedure.
2. Open / start C-III plus.
3. Wait for the plus VI to be recognized.
 - The **Serial No.** will display when the plus VI is recognized.
4. Select **Re/programming, Configuration**.

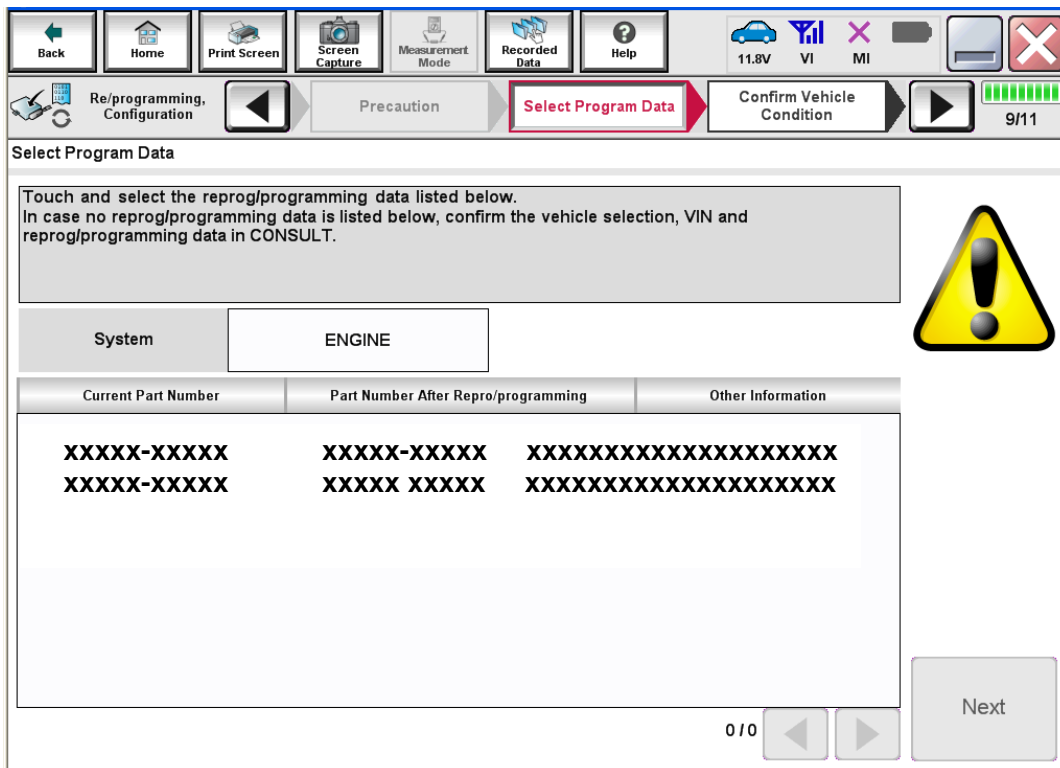
- In some cases, more than one new P/N for reprogramming is available.
 - If more than one new P/N is available, the screen in Figure 3 displays.
 - Select and use the reprogramming option that **does not** have the message “Caution! Use ONLY with NTBXX-XXX”.
- If you get this screen and it is blank (no reprogramming listed), it means there is no reprogramming available for this vehicle. Close C-III plus and refer back to ASIST for further diagnosis.

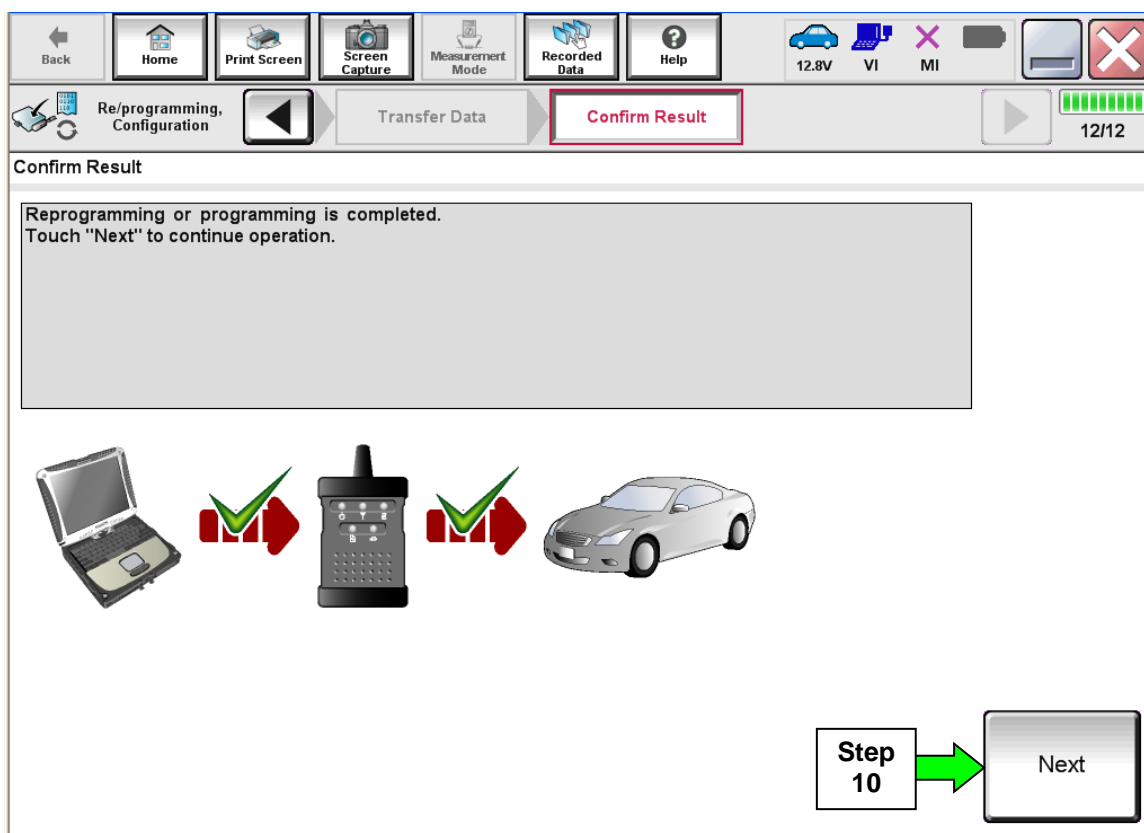
8. When the screen in Figure 4 displays, reprogramming is complete.

NOTE: If the screen in Figure 4 does not display (reprogramming does not complete), refer to ECM recovery on the next page.

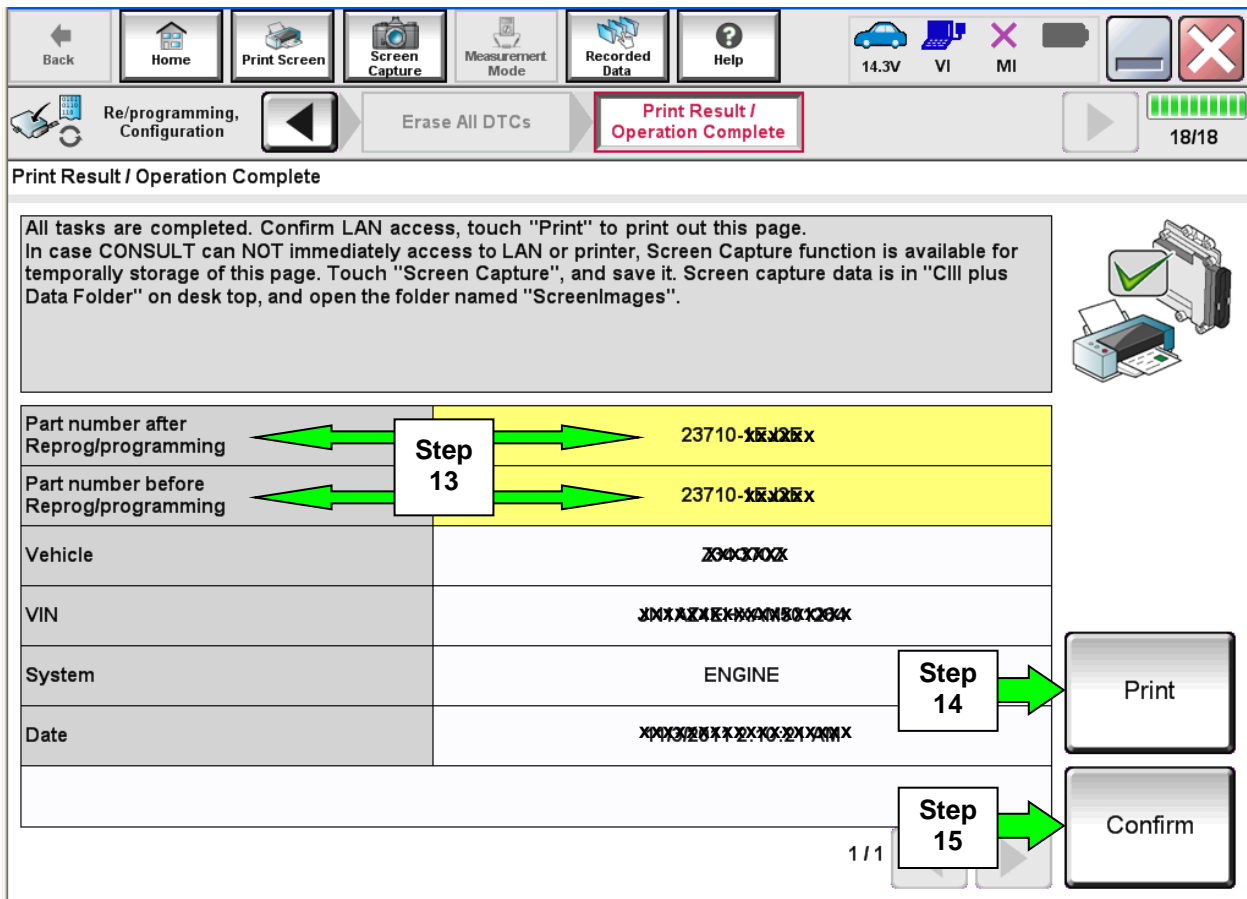
12. When the entire reprogramming process is complete, the screen in Figure 7 will display.

14. Print a copy of this screen (Figure 7) and attach it to the repair order for warranty documentation.
