Technical Bulletin

SERVICE BULLETIN					
Classification:	Reference:	Date:			
ΔT15-015ο	NTR15-0866	November 14, 2016

2013-2014 ALTIMA AND 2014-2016 ROGUE; MIL ON WITH DTC P0776, P1715 MAY HAVE HESITATION AND/OR LACK OF POWER

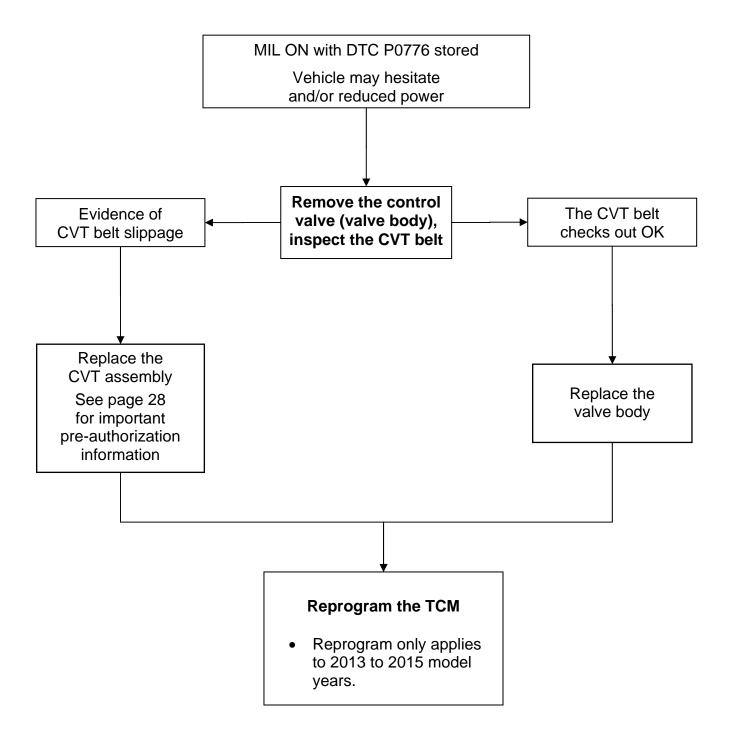
Repair Flow Chart

The MIL is ON with DTC P0776 (PC SOLENOID B – Pressure Control Solenoid "B" Performance/Stuck OFF) stored.

- P1715 (INPUT SPEED SENSOR) may be stored with DTC P0776.
- The vehicle may hesitate and/or have reduced power.

1. Refer to the **Repair Flow Chart** on page 2 for mechanical CVT repair.

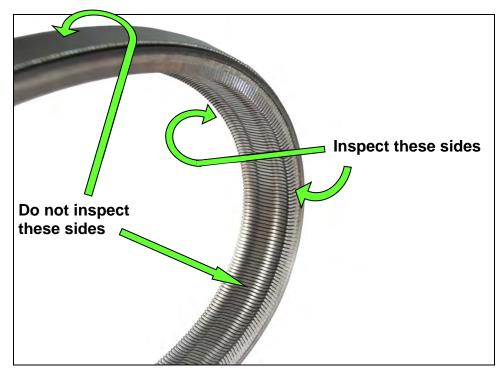
Figure 8

Using borescope J-51951 with mirror attachment, inspect the entirety of the two sides of the belt that come in contact with the pulleys (see page 7, Figure 8).
 Reference the pictures on pages 7 through 11 for comparison.

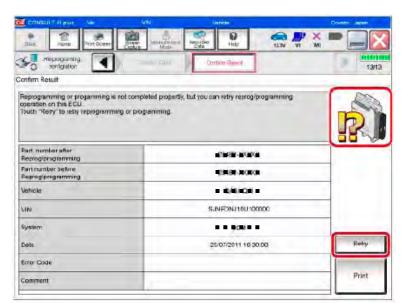
Figure 5B

If reprogramming does <u>not</u> complete and the "!?" icon displays as shown in Figure 5B:

- Check battery voltage (12.0–15.5 V).
- Ignition is ON, engine OFF.
- External Bluetooth® devices are OFF.
- All electrical loads are OFF.
- Select <u>retry</u> and follow the on screen instructions.
- "Retry" may not go through on first attempt and can be selected more than once.

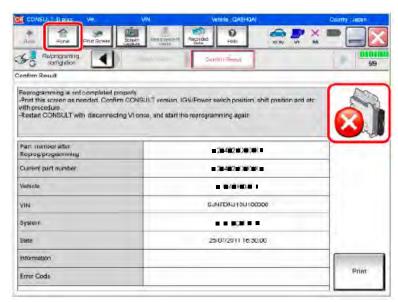
Figure 6B

If reprogramming does <u>not</u> complete and the "X" icon displays as shown in Figure 6B:

- Check battery voltage (12.0 – 15.5 V).
- CONSULT A/C adapter is plugged in.
- Ignition is ON, engine OFF.
- Transmission is in Park.
- All C-III plus / VI cables are securely connected.
- All C-III plus updates are installed.
- Select <u>Home</u>, and restart the reprogram procedure from the beginning.
