## CHARGING SYSTEM IMPROVEMENT

Prevost vehicles

## APPLICATION

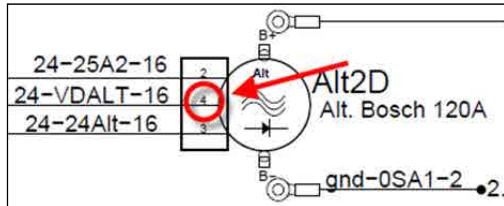
## 2.2 ALTERNATOR 24VD (DIRECT) ON PIN #4 CHANGED FOR 24VI (INDIRECT)

1. Inside rear electrical compartment (rear junction box), locate VECR module (FIGURE 10).
